## **WATERWORKS SYSTEM ASSESSMENT FOR THE TOWN OF OUTLOOK**

**JUNE 29, 2020  
JOB NO.: 177.62**

**TOWN OF OUTLOOK  
WATERWORKS SYSTEM ASSESSMENT 2020**

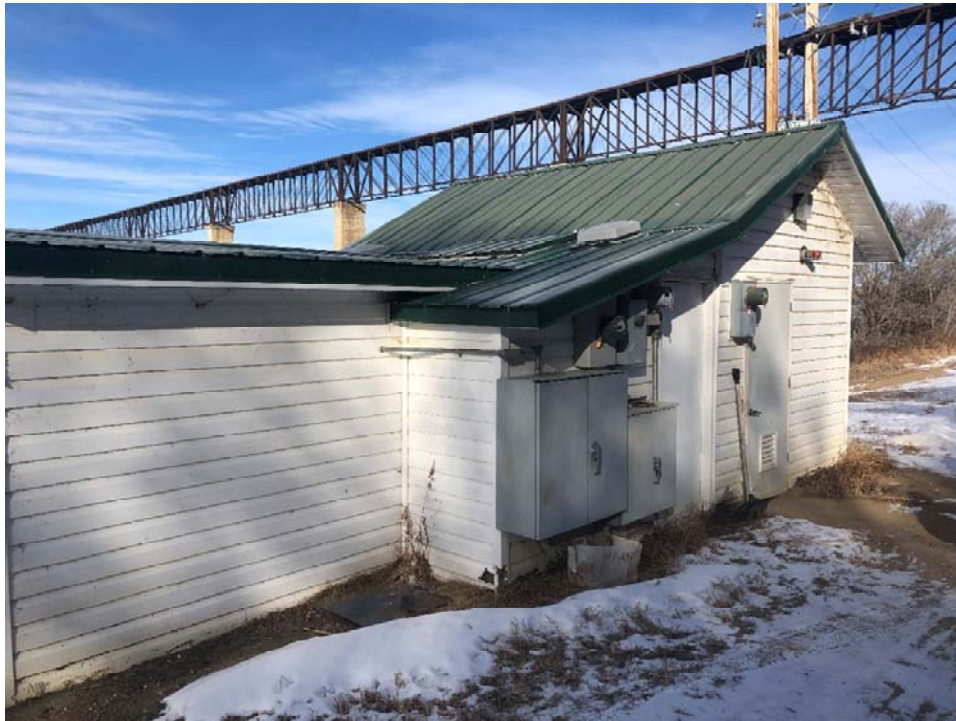
The facility is aging, and corrosion and general deterioration of structure and finishes was observed.

Raw water pumphouse building

During the inspection it was noted that the raw water pumphouse building and components were aging and in deteriorating condition. Corrosion was prevalent, particularly on the metal grating suspended overtop of the wet well, which provides access to most of the building. The pump installation was also noted to be unconventional and difficult for maintenance and removal of the pumps. The Operators noted that the intake screen location is often landlocked due to shifting sandbars in the river. Due to the extent of upgrades necessary and the operational issues, it is recommended that the Town plan to replace the intake and pumphouse system within the next 10 years. Depending on further evaluation of condition, the existing wet well structure may be suitable for re-use.

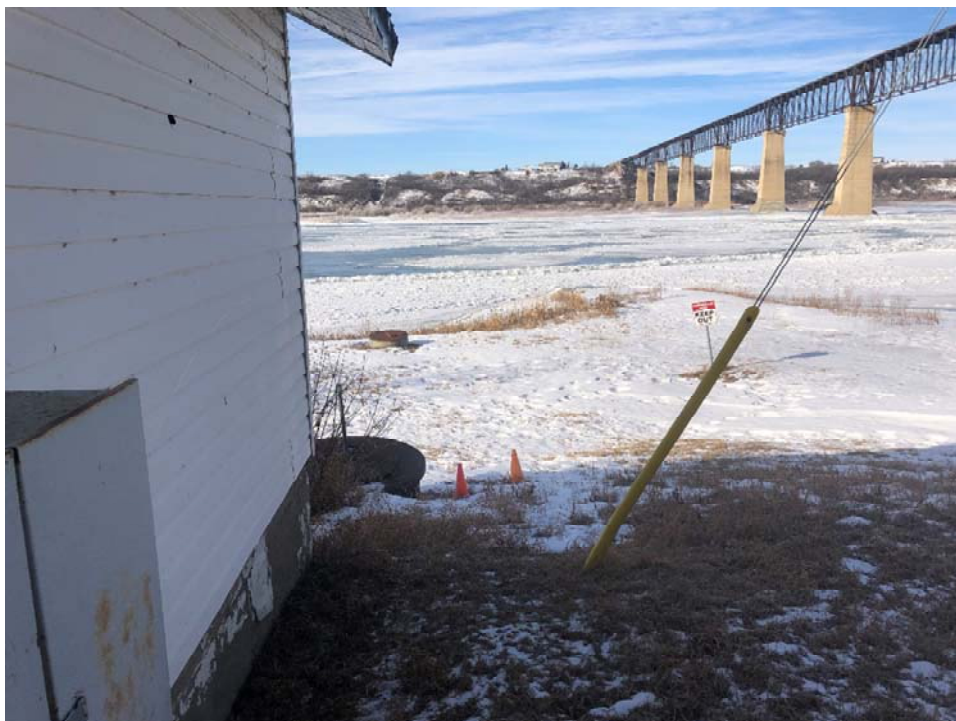
The raw water source for the Town of Outlook is the South Saskatchewan River. A 600 mm diameter intake pump, complete with 1,000 mm diameter steel intake screen are installed in the river, supplying water to a pumphouse on the riverbank. Water flows by gravity into the wet well under the pumphouse. The Operators reported that the intake screen experiences issues with sediment build-up and is occasionally landlocked by shifting sandbars along the river.

Intake screen location

Recommend re-arrangement of chlorine dosing and filtered water piping. Recommend replacement of raw water intake and pumphouse within 5-10 years. Explore options for dissolved organics removal.

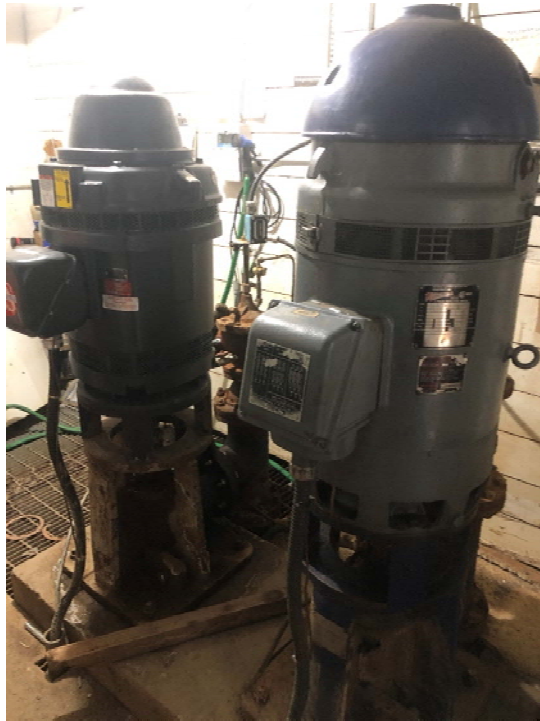
The pumps are driven by 60 hp, 3 phase, 460 V motors and are capable of pumping upwards of 56.8 L/s. One motor was replaced in 2019, while the other is reportedly original from the time of construction. A new turbine was also recently replaced on one pump. The pumps are run individually and manually alternated every few days. Due to the facility arrangement, pump removal is difficult.

Vertical turbine raw water pumps

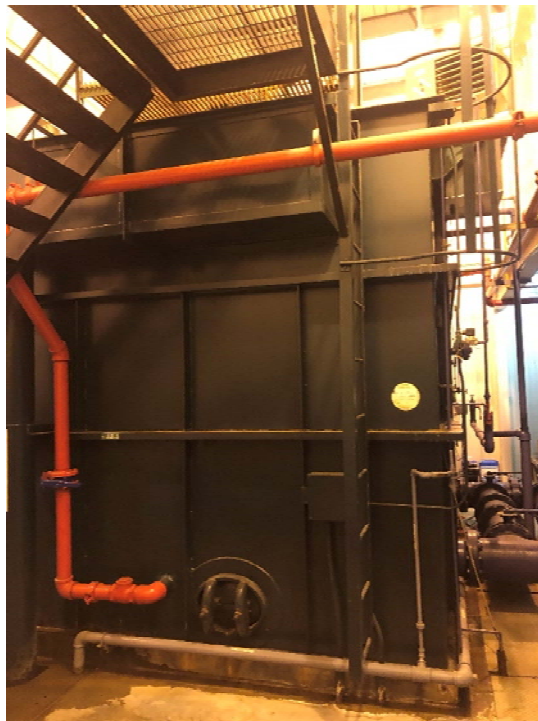
In general, the building appeared well maintained and no concerns with the building envelope or structure were observed. The exception to this is partial settlement of the grade supported slab below the filter unit. The settlement reportedly occurred shortly after construction and has not progressed since. Adjustments to the filter weirs have been made to account for the settlement.

Mixed media gravity filters

It was also noted that capacity shortfall of the filters may become an issue within the foreseeable future. Any upgrades planned for the treatment process should take this into consideration.

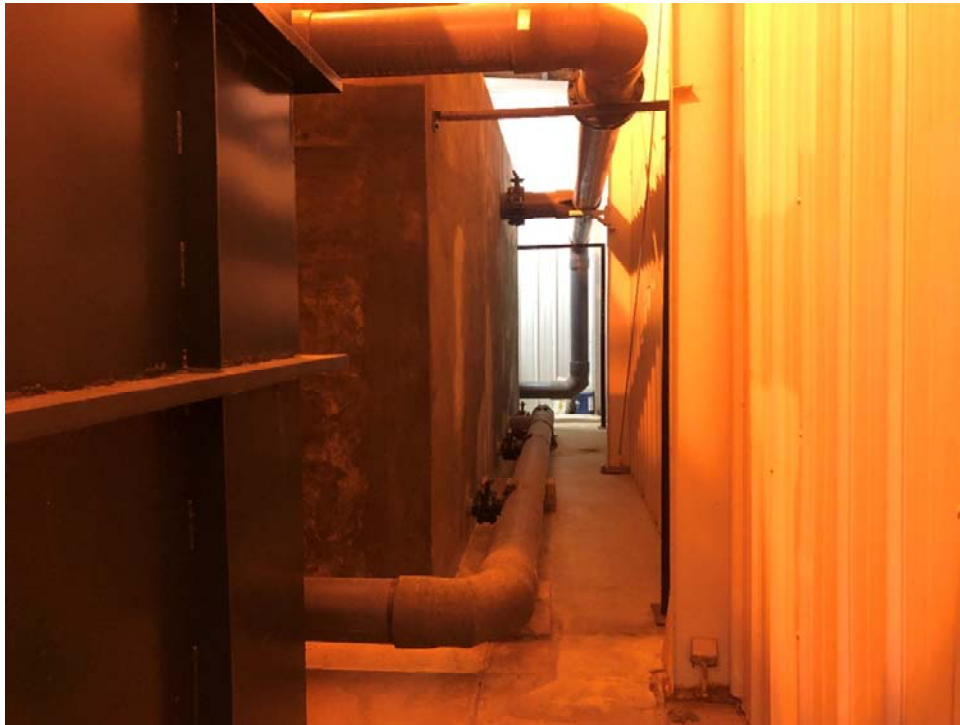
- backwash waste piping and floor drains were noted to discharge directly to the Town storm water system. Waterworks design guidelines recommend water plant wastewater be directed to sanitary disposal systems for treatment. At the time of inspection, water plant wastewater was still directed to the storm sewer;

Filter overflow and waste piping

Backwash waste piping and floor drains were noted to discharge directly to the Town storm water system. Waterworks design guidelines recommend water plant wastewater be directed to sanitary disposal systems for treatment. It should be noted that the volumes generated during backwash are likely to surcharge a sanitary sewer system. A containment and controlled release system may be required to mitigate this. An evaluation of the existing lagoon should also be conducted to ensure it has adequate capacity to handle anticipated backwash volumes.

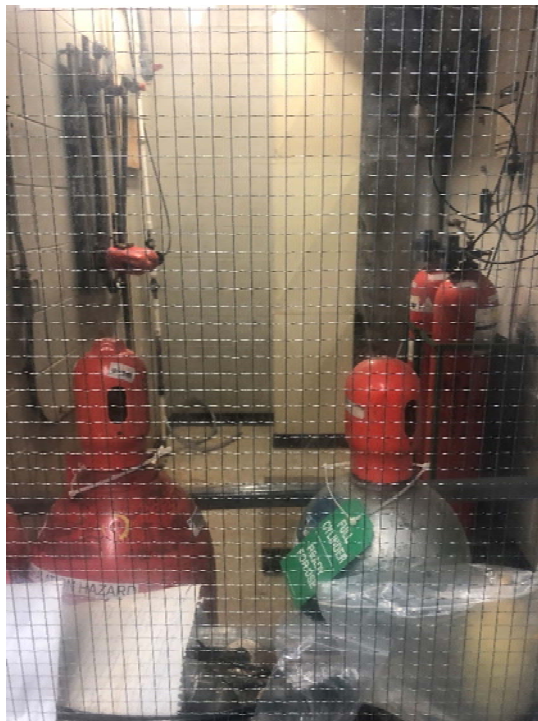
Disinfection is provided by dosing with pure chlorine gas. A separate room with dedicated ventilation and gas detection devices is provided for storage of gas cylinders. Access to the room is available from the plant exterior only in order to maintain separation of the gas from the rest of the building. Chlorine gas is dosed at a rate of 0.2 mg/L. This is less than the maximum use limit of 30 mg/L, as recommended by NSF60 regulations.

Chlorine gas room

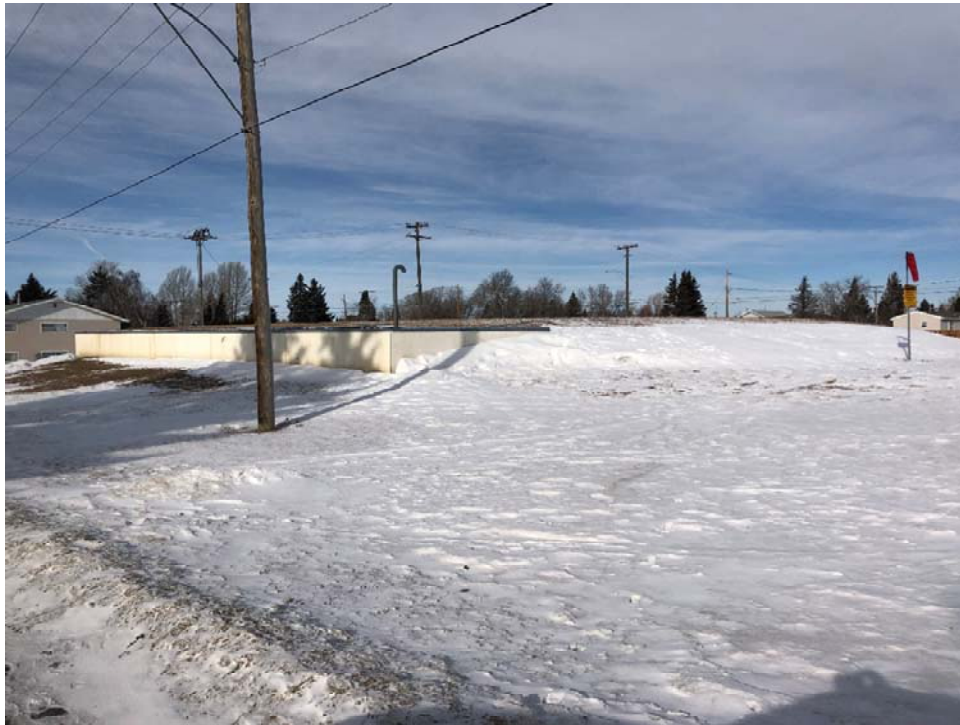
The external reservoir is a subgrade concrete structure with a storage volume of approximately 2,273,000 L, located approximately 50 m west of the plant. Access to the external reservoir is provided by an insulated hatch, which is kept locked at all times. Water from the external reservoir is transferred by gravity main to the concrete reservoir that serves as the foundation of the original water plant.

External reservoir

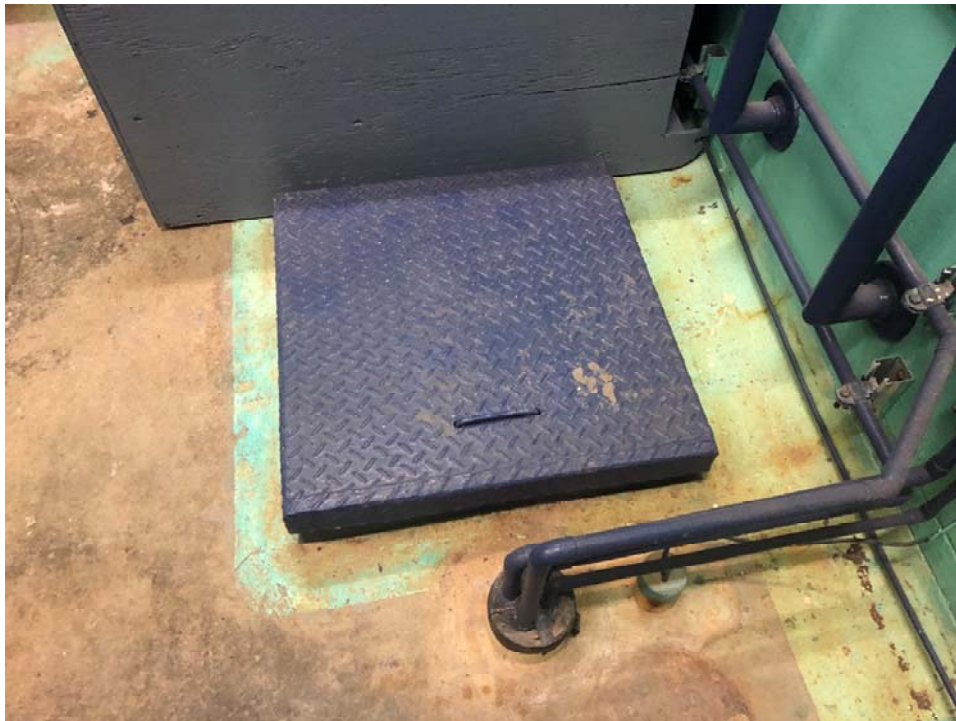
In the current arrangement, chemical is dosed directly to the pump well, which is also where the distribution pumps draw from. This scenario presents risk of inadequate mixing and contact time of the chemical prior to distribution, as well as stagnation of the water in the other reservoirs. This condition would only be in effect while the plant is making water.

Pump well access hatch

The primary concern observed during the inspection is the chlorine dosing arrangement. Currently chlorine is deposited directly to the pump well, which at times results in poor mixing and inadequate contact time between the chemical and filtered water prior to distribution. Without adequate contact time there is potential for viruses and pathogens to remain active and reach users. It is recommended that the chemical dosing and filter effluent treated water discharge to reservoir piping be reconfigured to eliminate this risk. Changes to the transfer piping and level control between the external reservoir and pump well would also be required.

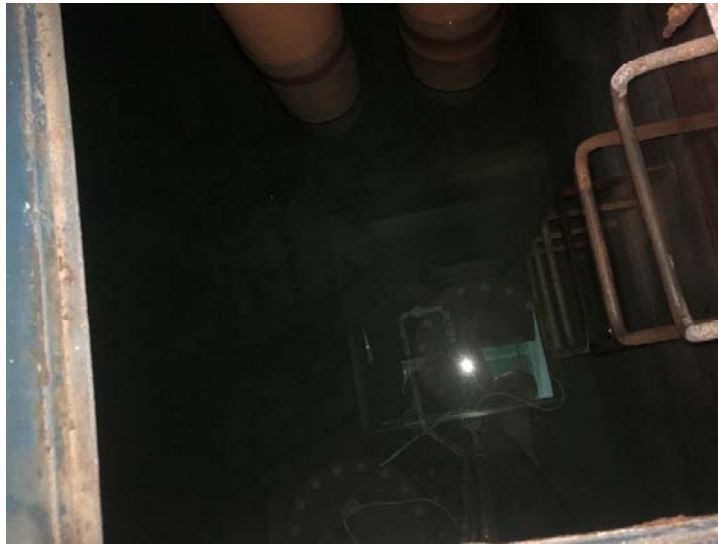
The operating level of the pump well is several metres below that of the two reservoirs, which necessitates transfer to and from the reservoirs by mechanical means. The distribution and transfer pumps are mounted in a dry pit, which is situated adjacent to the water plant reservoir and above the pump well. There are inherent risks associated with this arrangement, such as failure of the control valve or floats

controlling the pump well level resulting in flooding of the dry pit, or draining the pump well to a low level condition. Either scenario results in damage to the pumps and potential significant disruption to the supply of water to the Town.

Pump well and flow control valve (sub-surface)

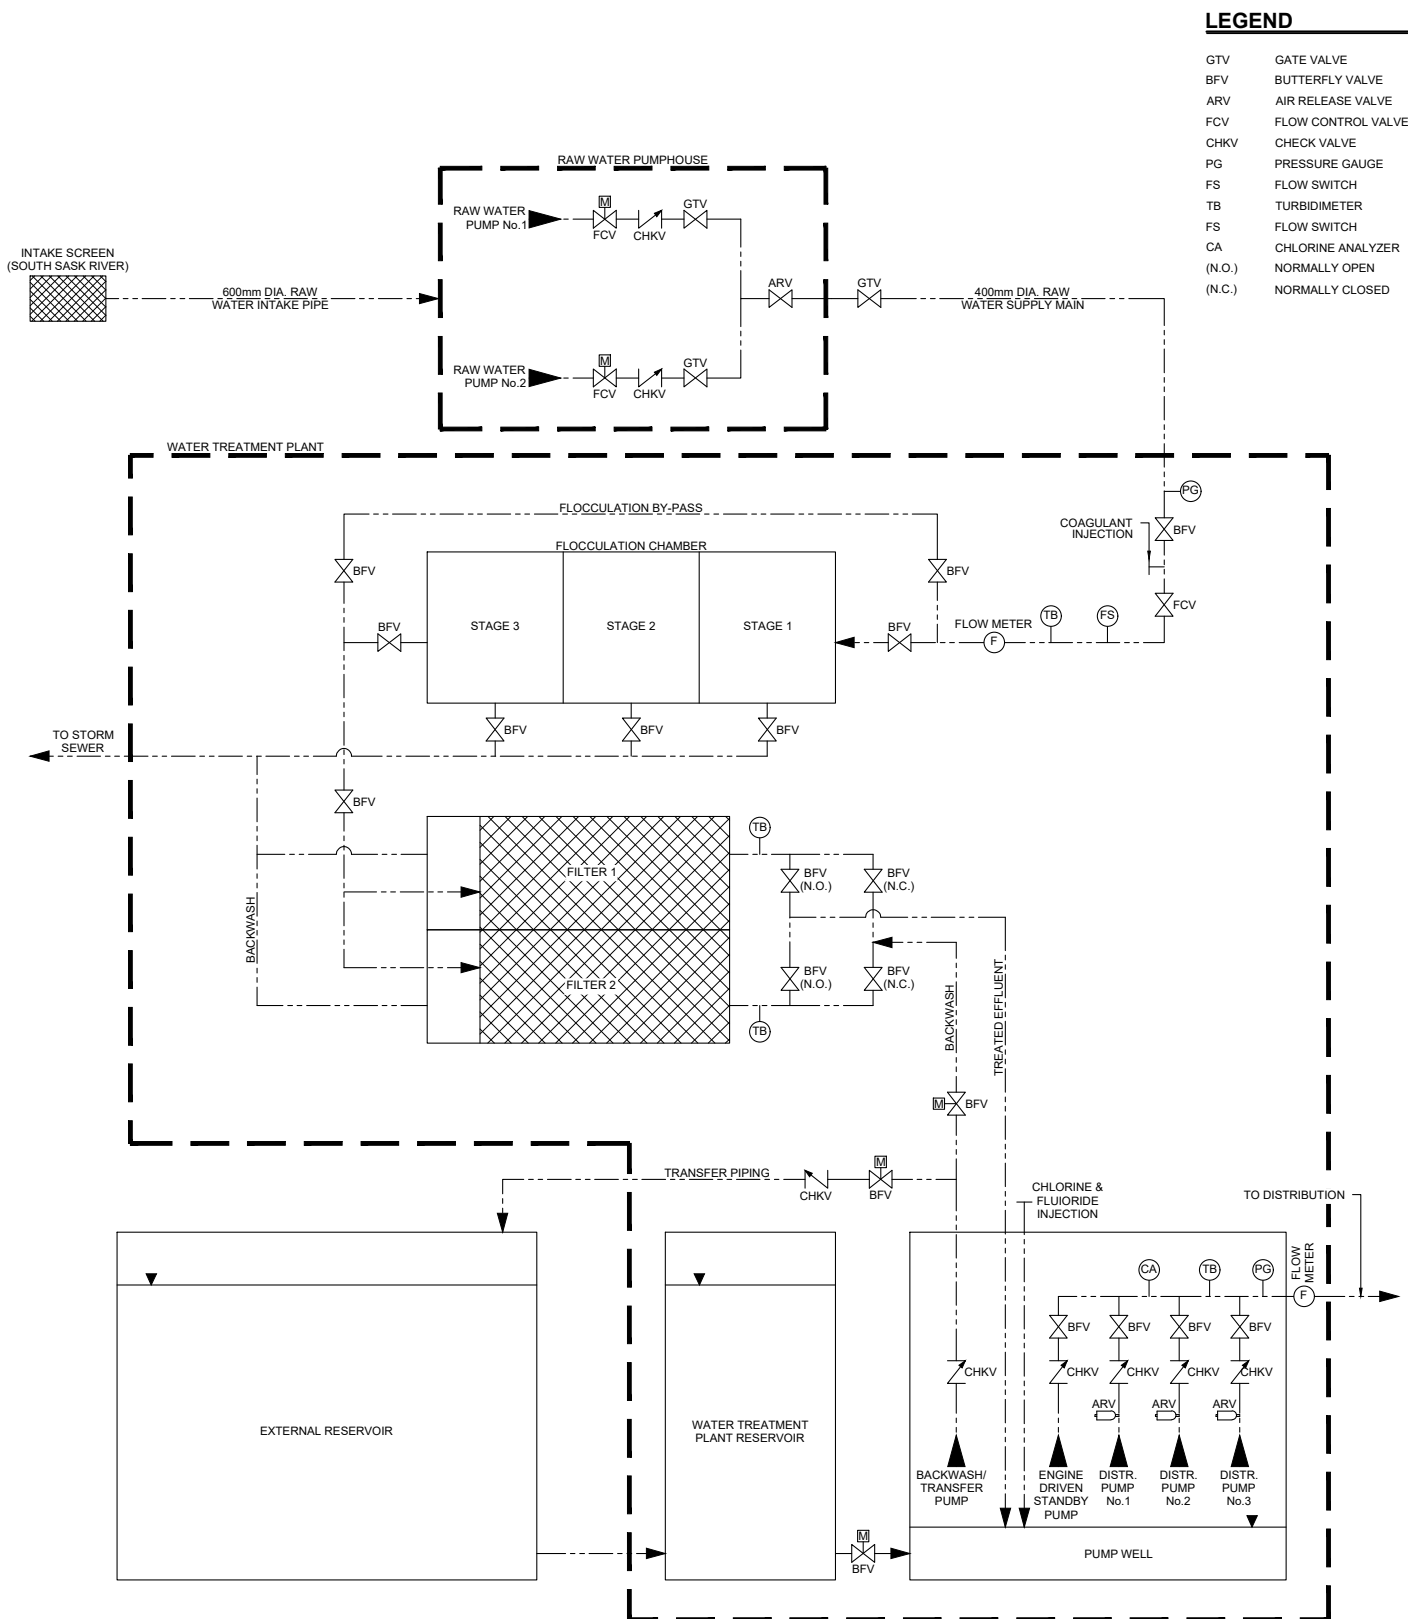
**FIGURE 1.0 - EXG. FLOW SCHEMATIC**

Treatment unit provides sufficient turbidity reduction but is not proficient in removal of dissolved organics. The disinfection arrangement is likely to provide inadequate contact time.
