Town of Outlook

TransCanada Trail Pedestrian Bridge Preliminary Bridge Repair Design Report

April 2014

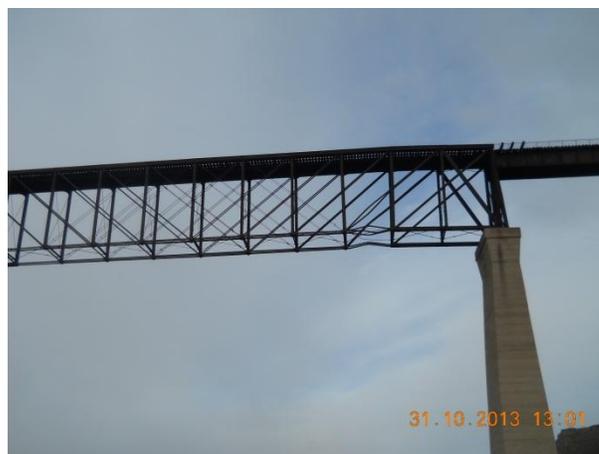
- Buckling and excessive deformation of bottom chord members and diagonals in truss T1, 3rd bay from the east end of the truss (see Figures 4-1 and 4-2; for designations see Figure 2-1).
- Buckling and significant deformation of bottom chord members in the 10th bay of trusses T1, T2 and T3.
- Approach girders colliding with and damaging the main span truss, bearing, and diaphragm at pier P1.
- Bearing anchors broken and excessive bearing movement at P1, and possibly more piers.
- Broken bearing anchors and loss of contact at concrete footings in East and West approach spans, at Bents W4, E1, E8, and E12.
- Loss of expansion at both abutments and piers P1, P2, P3, P4 (in part) and P9.
- Deformation (hump) in the top chord in span T1
- East approach superstructure sagging at the first bent.
- Damaged concrete pedestals in several approach span bents.

Figure 4-1
Buckling of Bottom Chord (T1 – Bay 3)

- Repair or replace buckled bottom chords and diagonal members in span T1, 3rd bay from the east end of the truss (see Figures 4-1 and 4-2; for designations see Figure 2-1).
- Approach girders colliding with and damaging the main span truss, bearing, and diaphragm at Pier P1.
- Bearing anchors broken and excessive bearing movement at P1.
- Broken bearing anchors and loss of contact at concrete footings in East approach spans, at Bents E1, E8, and E12.
- Loss of expansion capacity at East abutment and Pier P1.
- Deformation (hump) in the top chord in span T1
- East approach superstructure sagging at the first bent.
- Damaged concrete pedestals approach span bents.

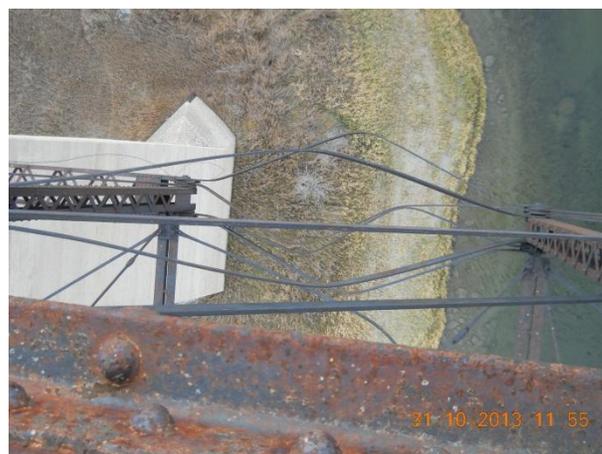
Figure 4-2
Buckling of Bottom Chord (T1 – Bay 3)

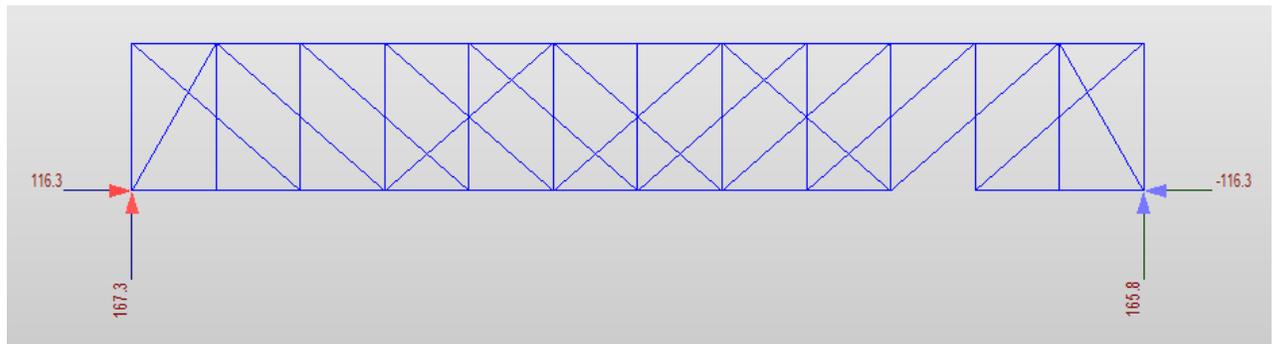
Figure 6-2
Current Truss Configuration (Pin – Pin with Buckled 3rd Bay)

In addition to the force exerted on the T1 truss end diaphragms by the approach girders, Pier P1 has moved towards the west by approximately 21” and as a result, the roller support at the east side of T1 has reached the maximum amount of travel and is bearing against the fixed approach span support leg. In order to reasonably estimate the force exerted on this fixed support (and the required jacking force to re-establish a gap between the bottom chord bearing and the approach support leg), we modeled the truss supports with pinned-pinned boundary conditions and removed the buckled 3rd bay, as shown in Figure 6-2.

The truss support conditions shown in Figure 6-2 vary significantly from the original design. Further analysis is essential at the detailed design phase to confirm that the proposed methodology for stabilizing the truss can be done safely and minimizes the risk of sudden release of energy.

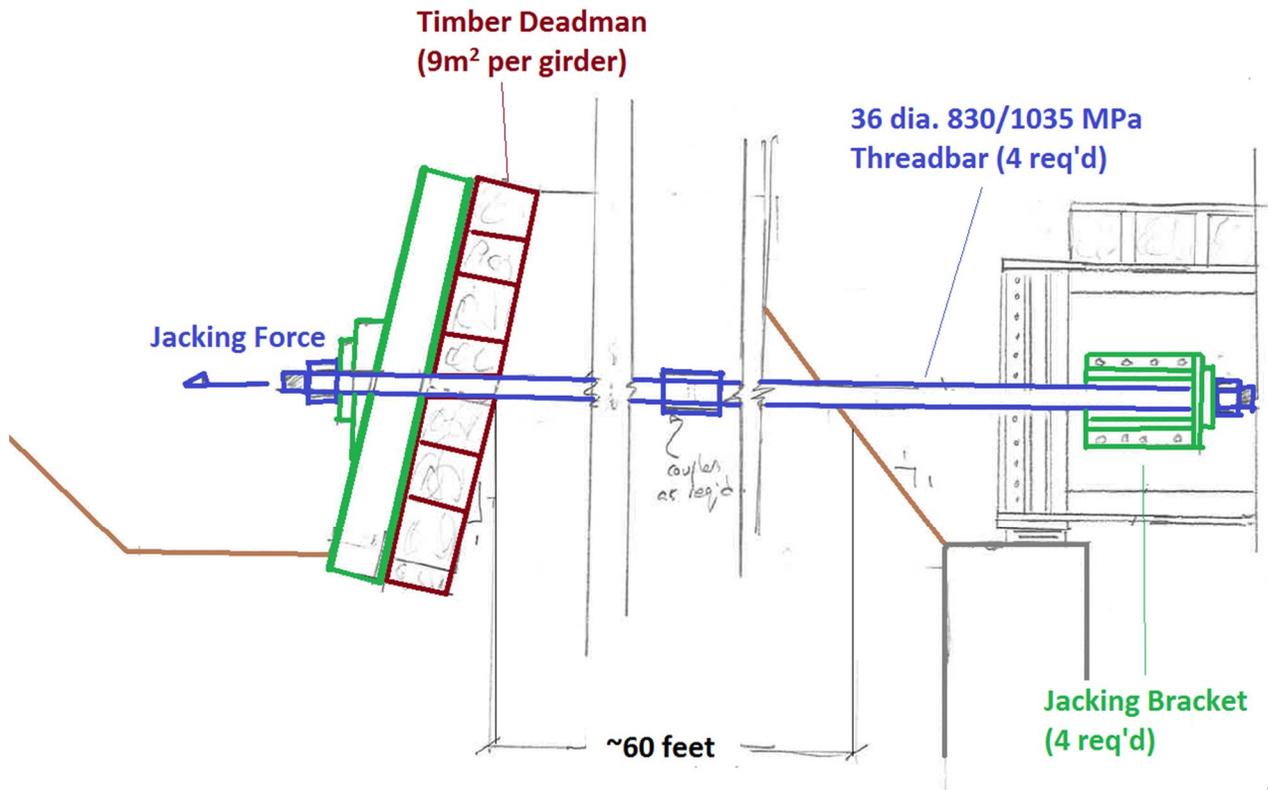
Figure 7-1
Abutment Deadman and Jacking Configuration

In order to jack the approach spans towards the east abutment, a deadman footing should be constructed approximately 60 ft (18.29 m) east of the east abutment. Using Dywidag threadbars and fabricated steel brackets either side of each girder, the threadbars would be post-tensioned to 10% of ultimate capacity to engage the approach spans. Prior to post-tensioning the threadbars, we recommend that the approach span ties be installed to provide continuity over the approach bents and allow the jacking force to be distributed evenly between the approach bents (see Section 7.1.4).

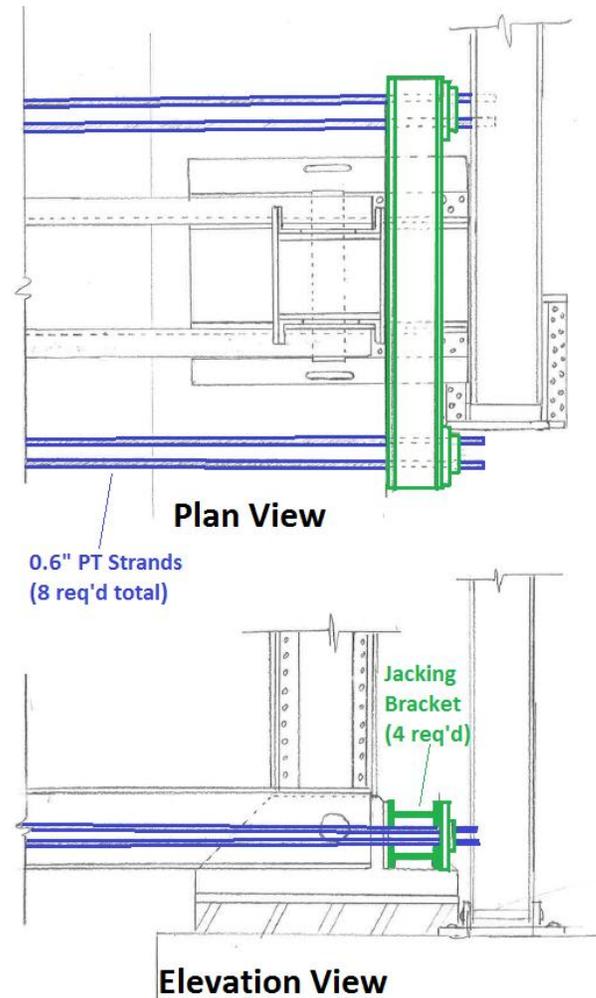
Figure 7-2
Truss Jacking Brackets

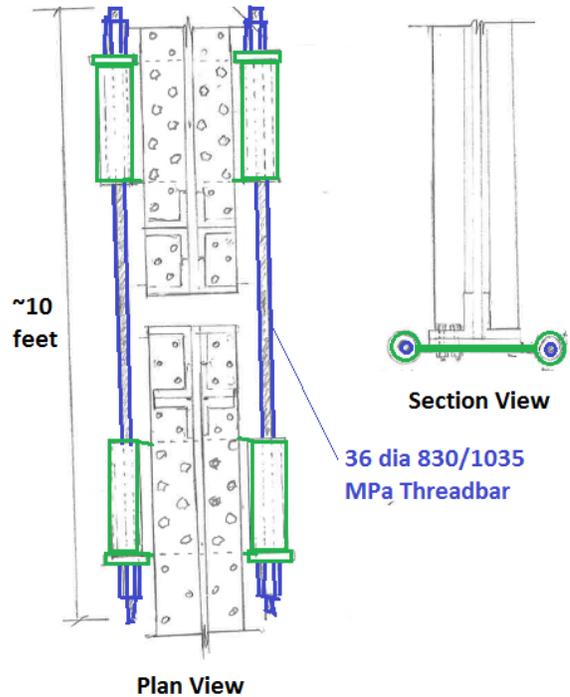
Additionally, the settlement has resulted in the approach girders bearing against the truss span stringer end diaphragm of truss T1, damaging the end diaphragm and stringers. Once support at the downslope piers is reinstated, it will remove the large force currently being exerted on the truss end diaphragms.

Figure 7-3
Approach Girder Ties

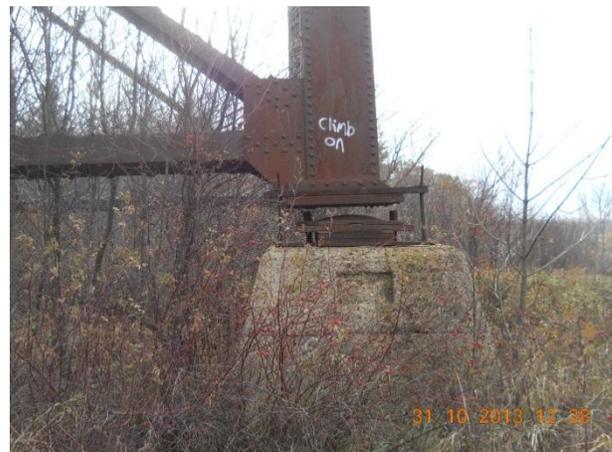
Figure 7-4
Settlement of Downslope Piers (E8 Shown)

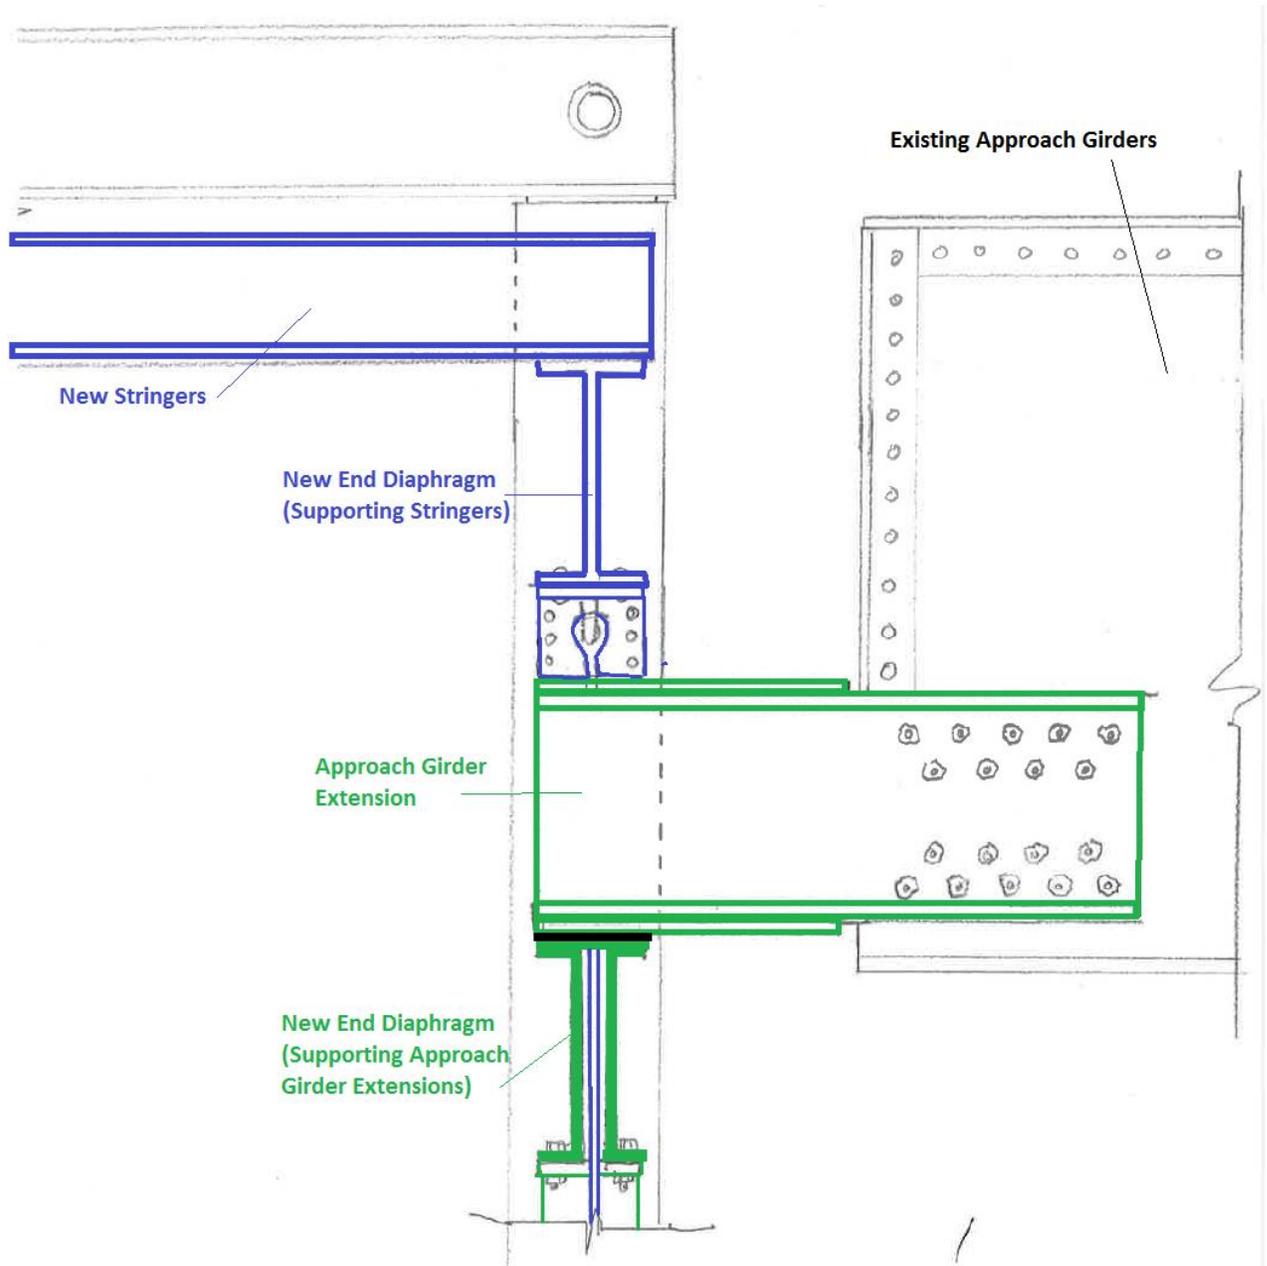
Figure 7-5
Extension of Approach Girders and New Support Diaphragm at Pier 1

Due to the movement of Pier P1, the truss roller bearing above Pier P1 has closed the 21" gap between the bearings at the time of construction and has contacted the fixed bearing supporting the approach support leg. This removal of the capability of additional movement has resulted in the compression and buckling of the bottom chord. Once the support of the approach spans has been transferred to the truss end verticals, the truss roller bearings should be removed and replaced with a suitable replacement bearing. This operation will involve the installation of a jacking frame and will require that the truss span is sufficiently lifted to allow the replacement of the bearings. This operation will likely be performed prior to releasing the temporary post-tensioning along the bottom chord.

The damaged stringers and end diaphragm in Bay 1 of truss T1 should be replaced to restore the original capacity. Additionally, we recommend that the approach span support bent above Pier P1 be removed and the approach span extended to rest on a steel diaphragm beam spanning between the end vertical members of the T1 truss (see Figure 7-5). A new bearing allowing horizontal movement should be installed at this time to allow for any future movement of the approach span towards the river.

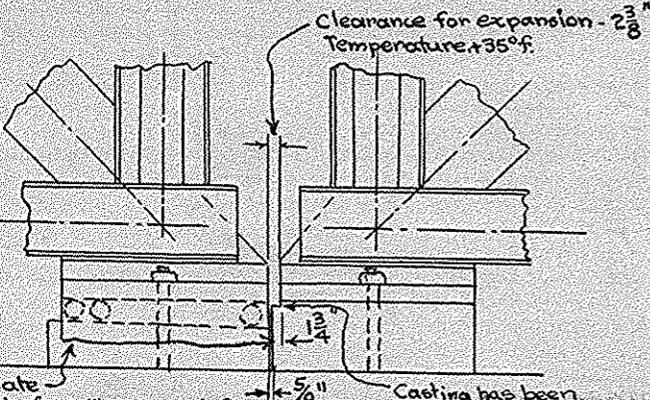
DETAILS OF TRUSS BEARINGS - PIER 14

Curtain plate (does not interfere with expansion) ← 5/8" Casting has been chipped back 1 3/4" AH.

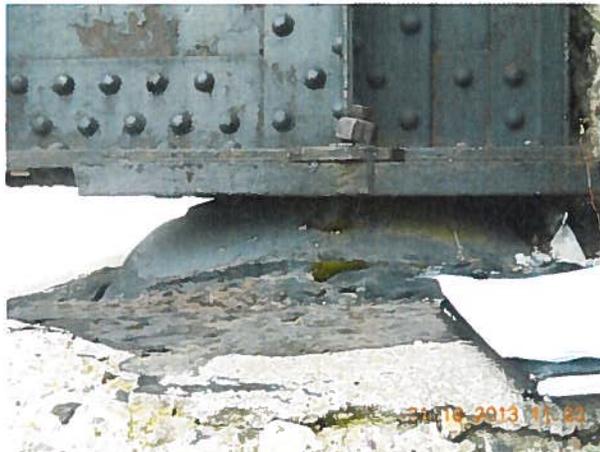
From our review, we noted that the anchor bolts at the abutment bearings were bent back from movement of the approach spans (**Photo 1**). Approx. 1" (25 mm) of movement was recorded.

Photo 1 - Bent Anchor Bolts at West Abutment

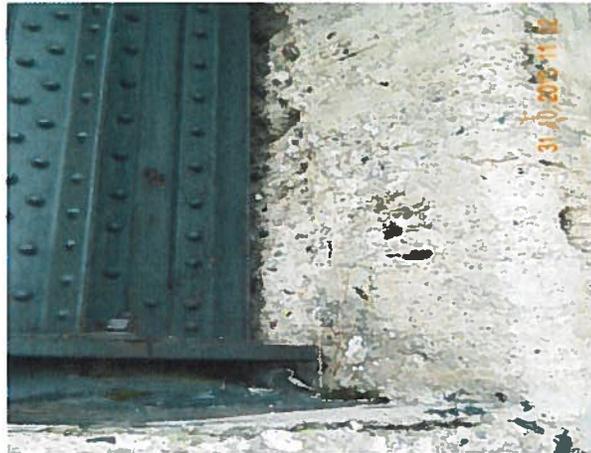
We also noted that concrete from behind the end plate of each approach span girder had been chipped away over time to make room between the girders and the abutment ballast wall (**Photo 2**).

Photo 2 - Chipped Concrete Ballast Wall at West Abutment

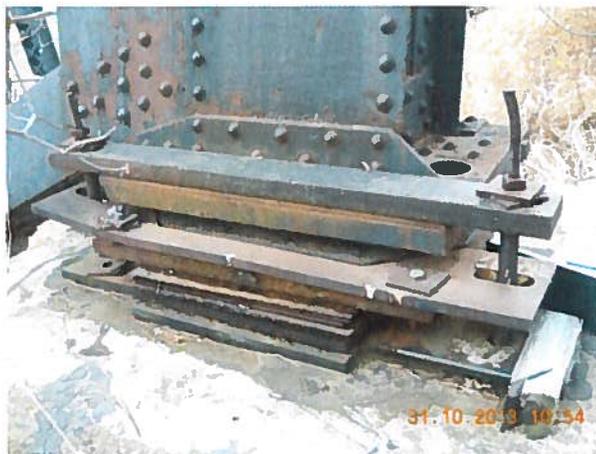
Approach Span bearings at supports W1, W2, W3, & W5 had no shim plates or gaps between the bearing plates. However, both bearings at support W4 showed signs that the support bents are no longer bearing on the concrete footing, including gaps between the spherical bearing plates, as well as shim plates at the north bearing. The north bearing had 3-1/2" (90 mm) of shim plates below the spherical bearing sole plate as well as an approx. 1-1/4" (30 mm) gap between bearing plates (**Photo 3**).

Photo 3 - North Bearing at Steel Bent W4

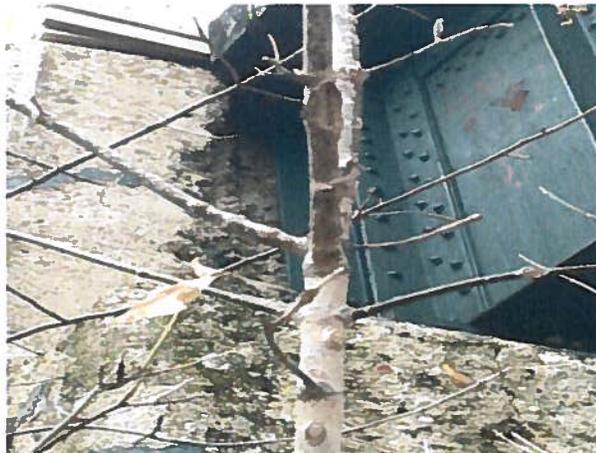
Similar to the west approach spans, similar items were recorded on the east side of the bridge. The abutment ballast wall had approx. 12" (300 mm) of concrete chipped away to make room between the girders and the concrete ballast wall (**Photo 5**).

Photo 5 - Chipped Concrete at East Abutment Ballast Wall

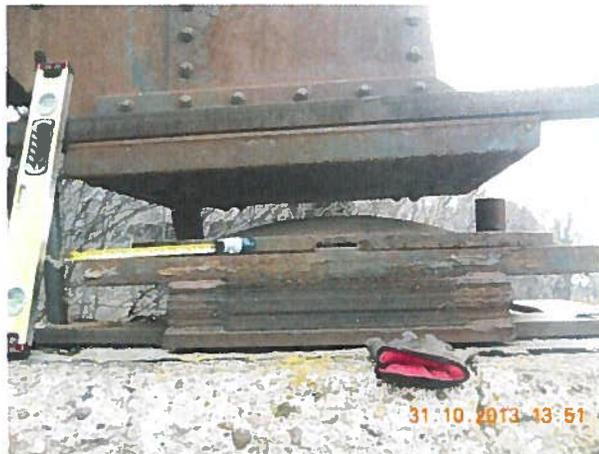
- E1 – ¾" (19 mm) gap, 3" (75 mm) of shim plates added, approx. 2" (50 mm) or relative movement between the bearing and the footing;
- E2 - 3" (75 mm) of shim plates added, approx. 2" (50 mm) or relative movement between the bearing and the footing;
- E7 – 3.5" (87 mm) of shim plates added, ½" (13 mm) of relative movement;
- E8 – 4.5" of shim plates, 4.5" (113 mm) gap between bearing plates 3.75" (94 mm) of relative movement (**Photo 6**);
- E9 – 4.5" (113 mm) of shim plates, no gap between bearing plates, ½" (13 mm) of relative movement;
- E10 - 4.5" (113 mm) of shim plates, no gap between bearing plates, ½" (13 mm) of relative movement;
- E11 – 3" (75 mm) of shim plates, no gap between bearing plates;
- E12 – ¾" (19 mm) of shim plates, ½" (13 mm) gap between bearing plates, 1" (25 mm) of relative movement.

Photo 6 - Bearing Movement at E8 (Similar for Other Bents)

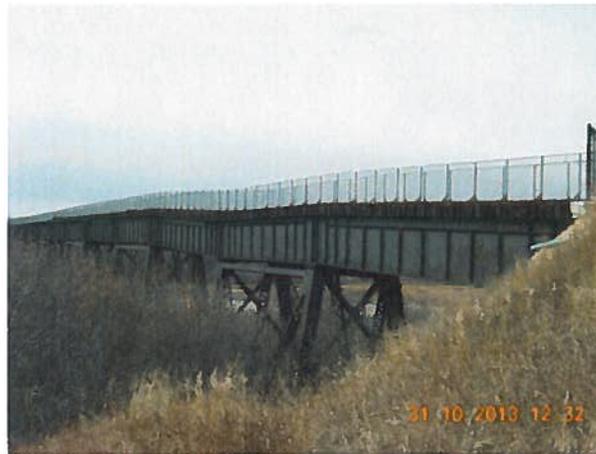
As mentioned in Section 2.1, from our visual review of the east approach span elevations (recorded with a laser level), we determined that there has been movement between spans; particularly between E2 and E3, where a visible dip was recorded, with a relative dip of over 18" (450 mm) between supports (**Photo 7**).

Photo 7 - Elevation Difference between Adjacent Approach Spans (East Approach)

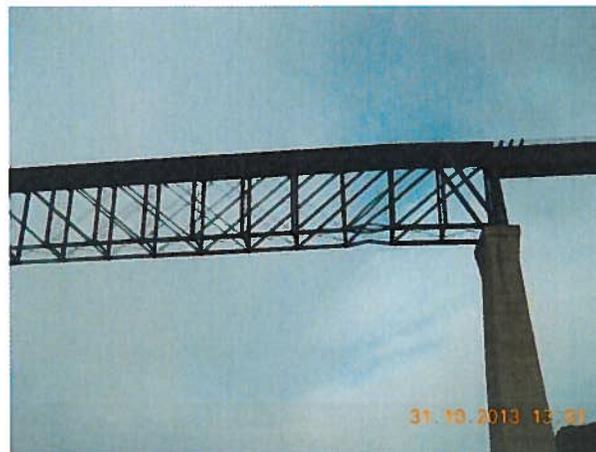
From a review of the main truss spans from the walking deck, we recorded that the main span bearings at pier P1 have clearly failed since they were unable to accommodate excessive relative movement of approximately 21" (530 mm) and have collided with the most easterly truss (T1) (**Photo 8**), damaging the end plan brace and breaking the riveted connections (**Photo 9**).

Photo 8 - Movement of East Approach Span at P1

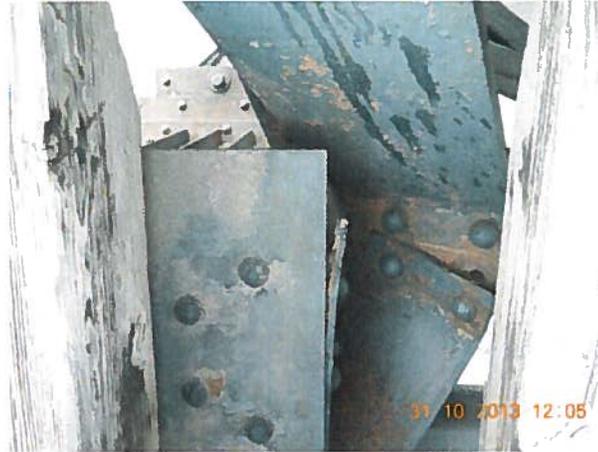
Photo 9 - Damage to End Plan Brace on T1

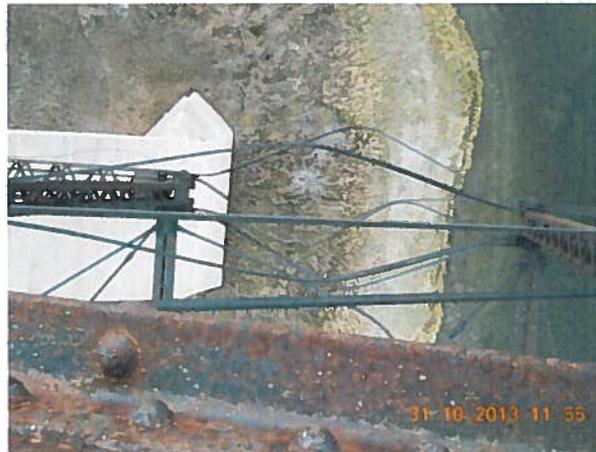
Buckling of the bottom truss chord was recorded on truss T1 in the 3rd bay and 10th bay from the east end of the truss respectively (see General Arrangement plan). The 10th bay exhibited only a small bow in the bottom chords while the 3rd bay exhibited significant buckling (**Photo 10**).

Photo 10 - Buckled Bottom Chord Bracing (3rd Bay T1)

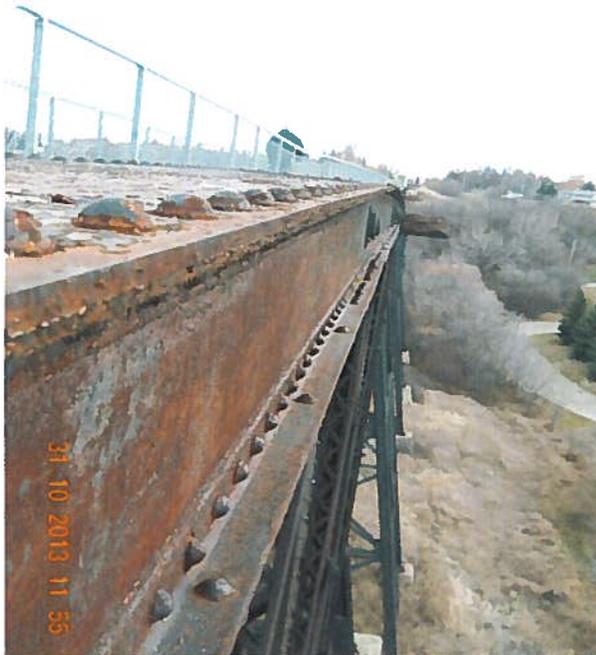
At the location of the 3rd bay a hump also exists in the truss of approximately 15" (375 mm) relative to the end of the truss (**Photo 11**) as a result of pressure from the east approach spans.

Photo 11 - Hump in Truss T1 due to Movement of Approach Span

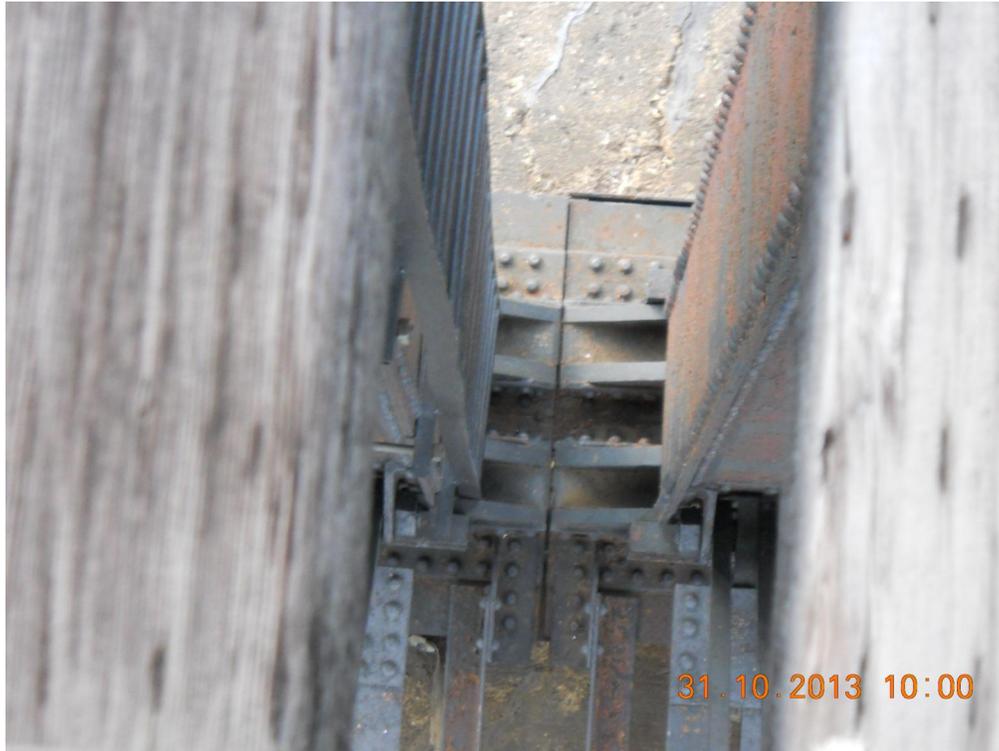
20131031 - Photo_07 - No gap between main truss spans, typical for 3 locations

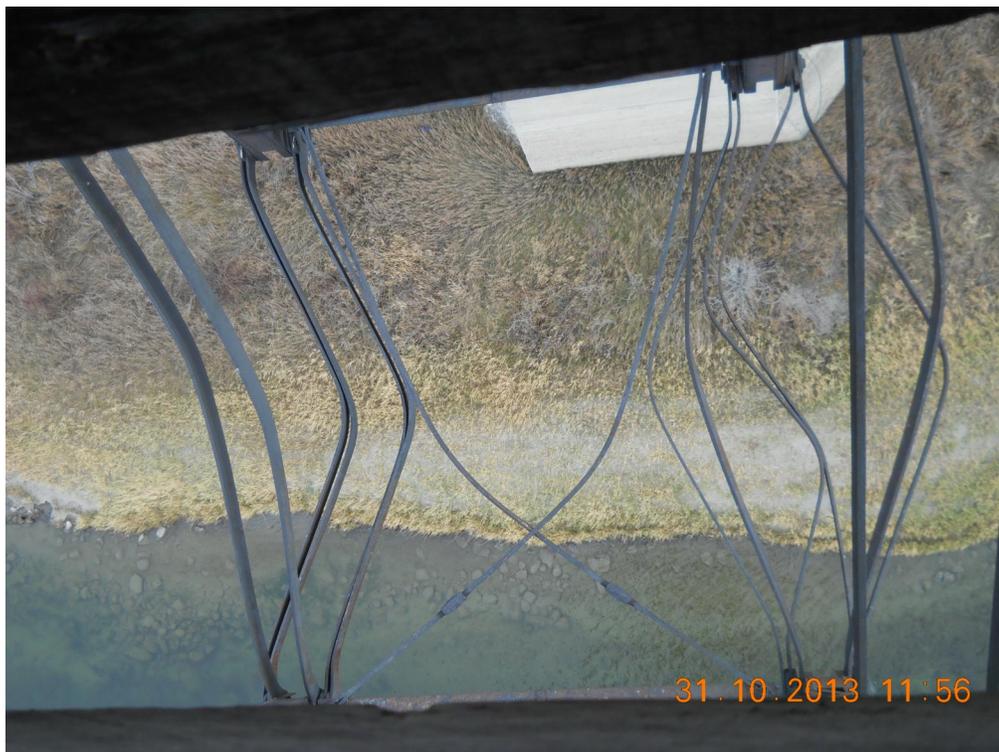
20131031 - Photo_08 - Buckled bottom truss chords on truss T1 bay 3

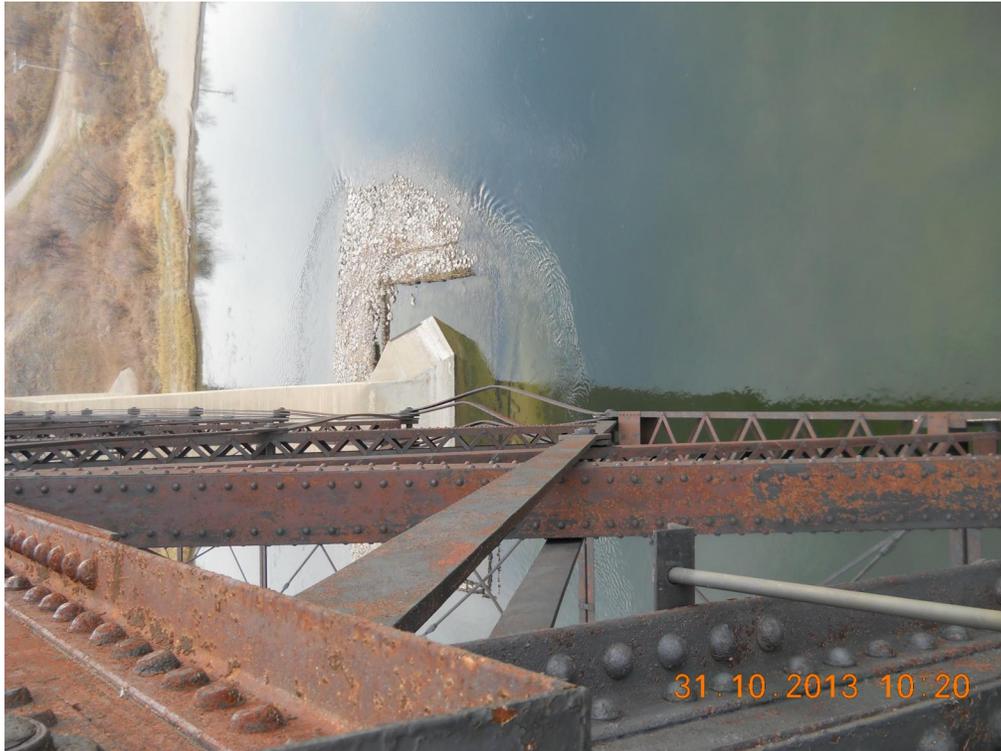
20131031 - Photo_09 - Buckled bottom truss chords on truss T1 bay 10

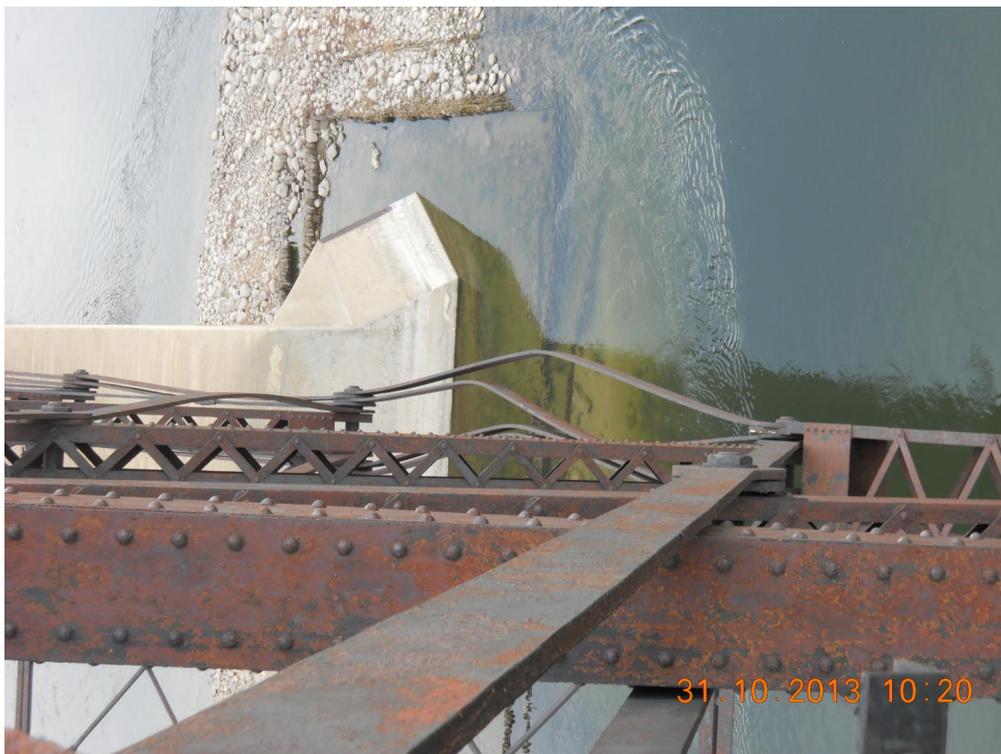
20131031 - Photo_10 - Buckled bottom truss chords on truss T1 bay 10

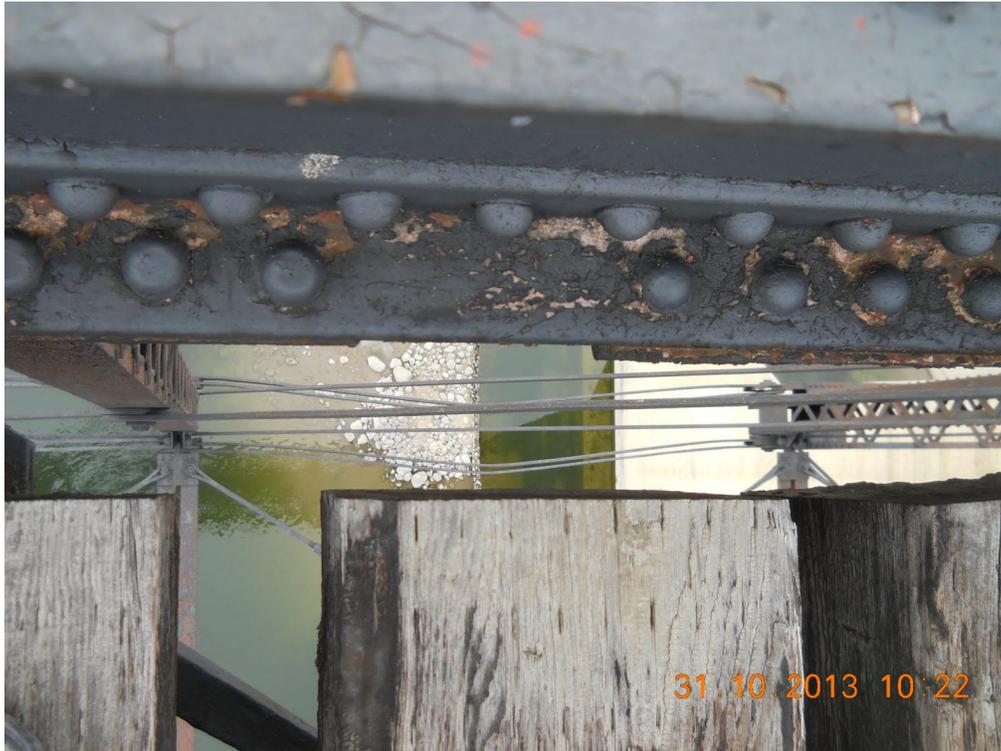
20131031 - Photo_11 - Buckled bottom truss chords on truss T2 bay 10

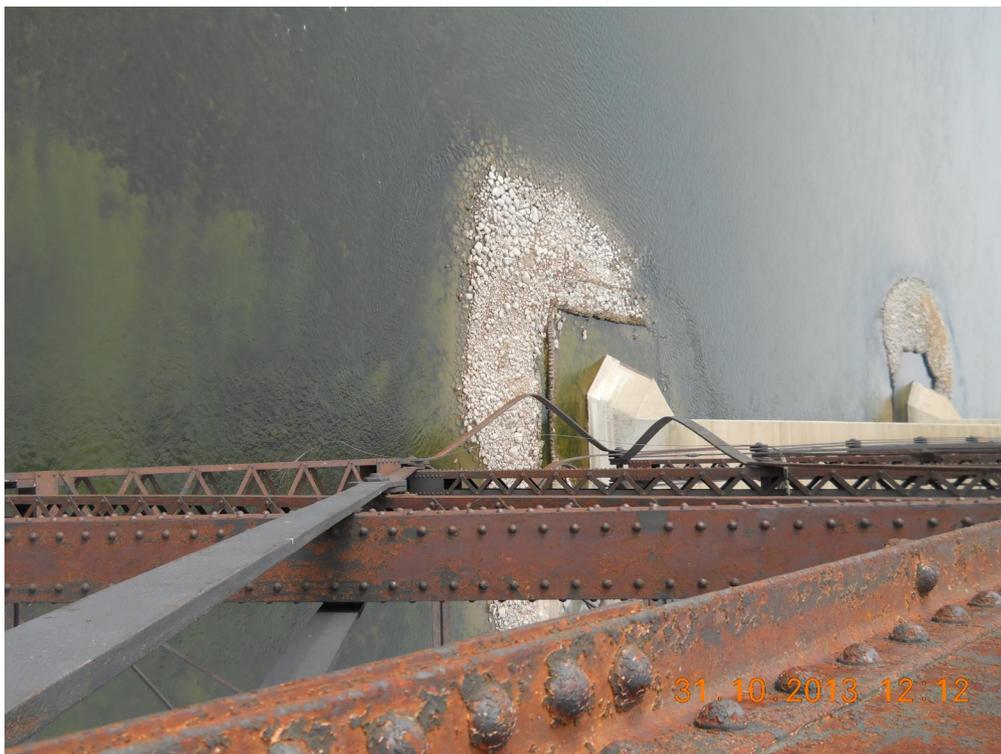
20131031 - Photo_12 - Buckled bottom truss chords on truss T1 bay 3

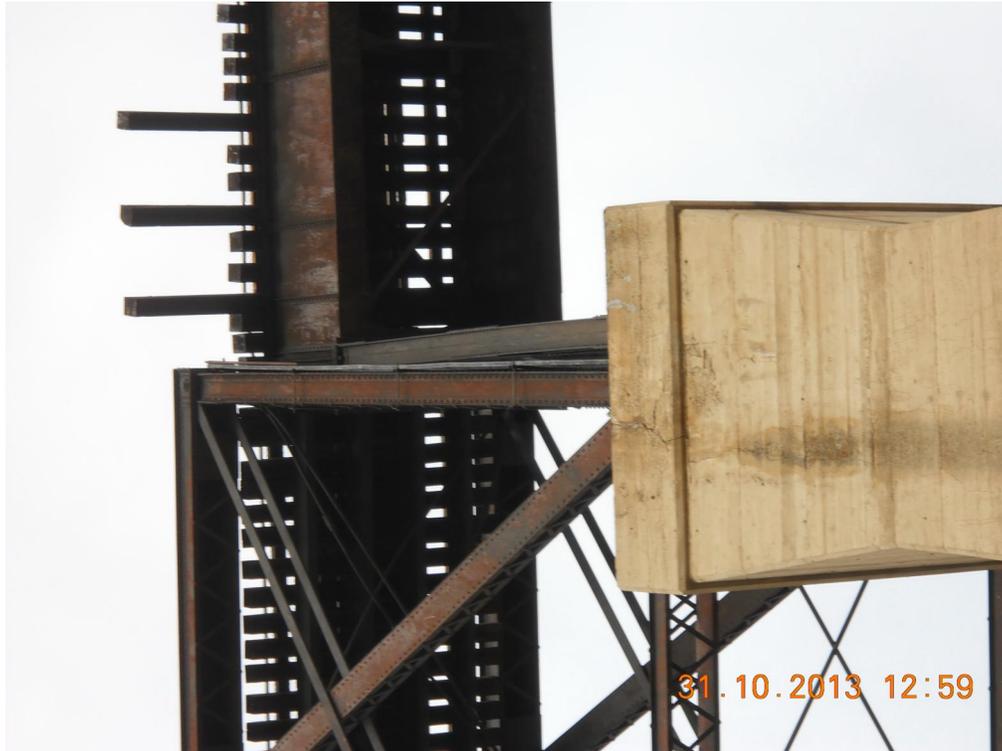
20131031 - Photo_13 - Collision between truss T1 and east approach spans at pier P1

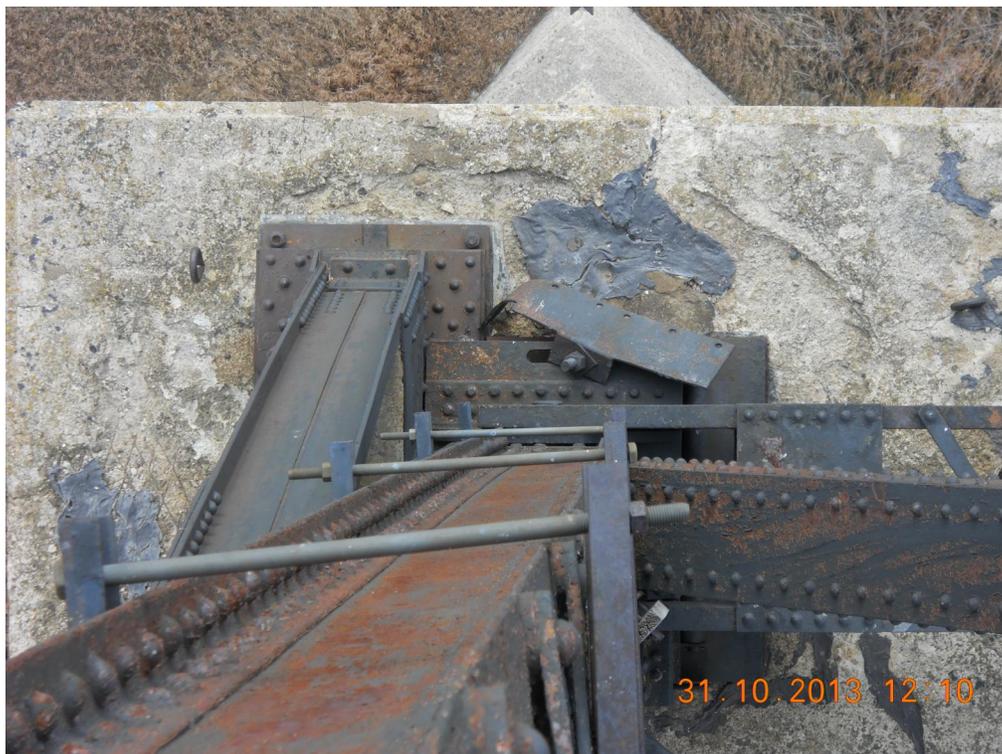
20131031 - Photo_14 - Failed bearing at pier P1

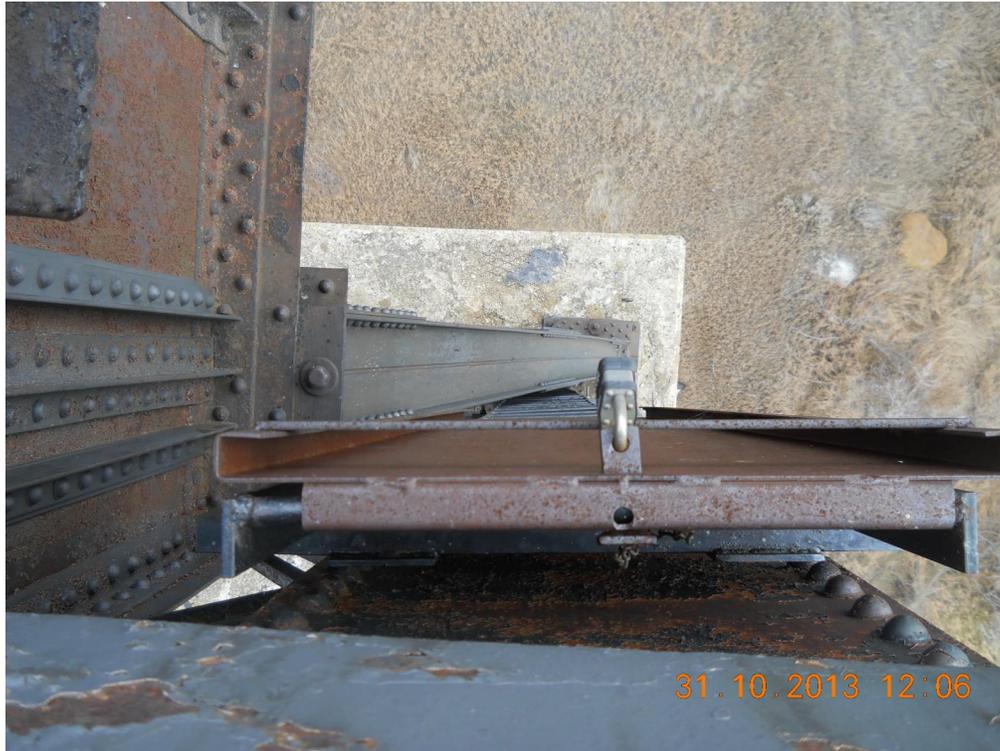
20131031 - Photo_15 - Looking down at collision between truss T1 and east approach spans at pier P1

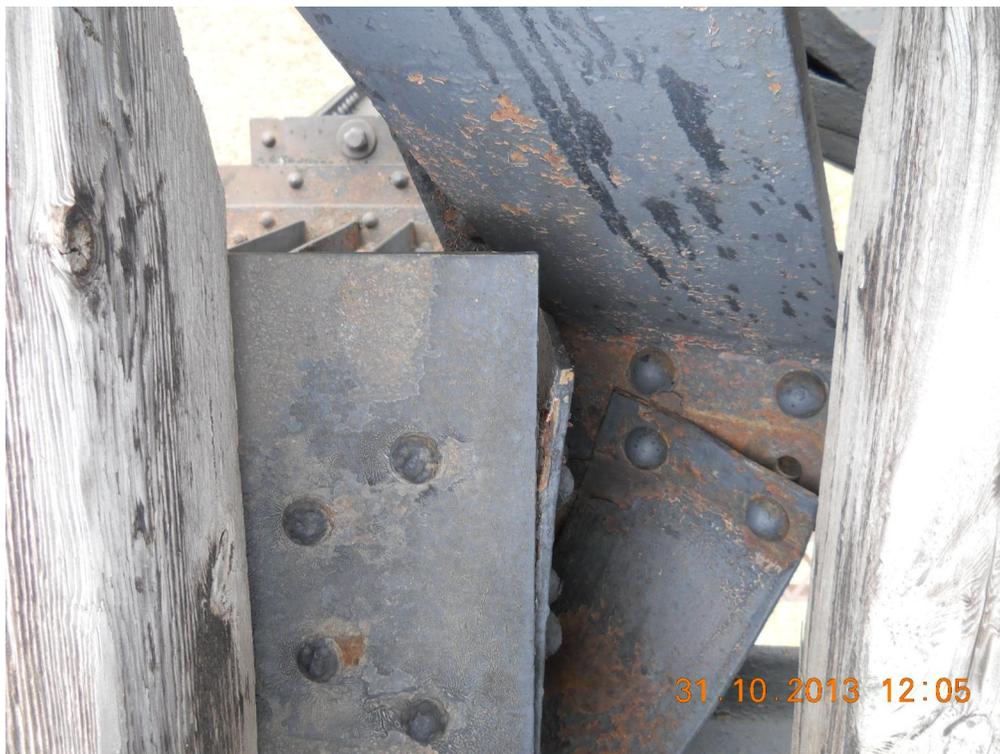
20131031 - Photo_16 - Deformed bracing at east end of truss T1 from collision with approach spans

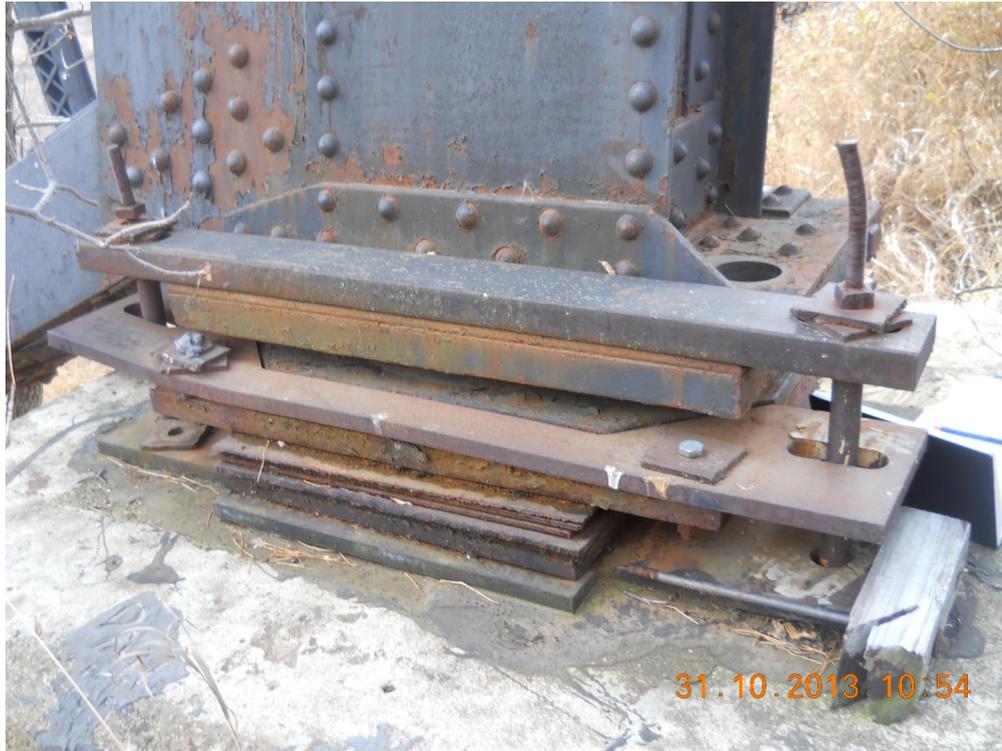
20131031 - Photo_17 - Shim plates added below bearing seat at west approach span support, typical 2 locations

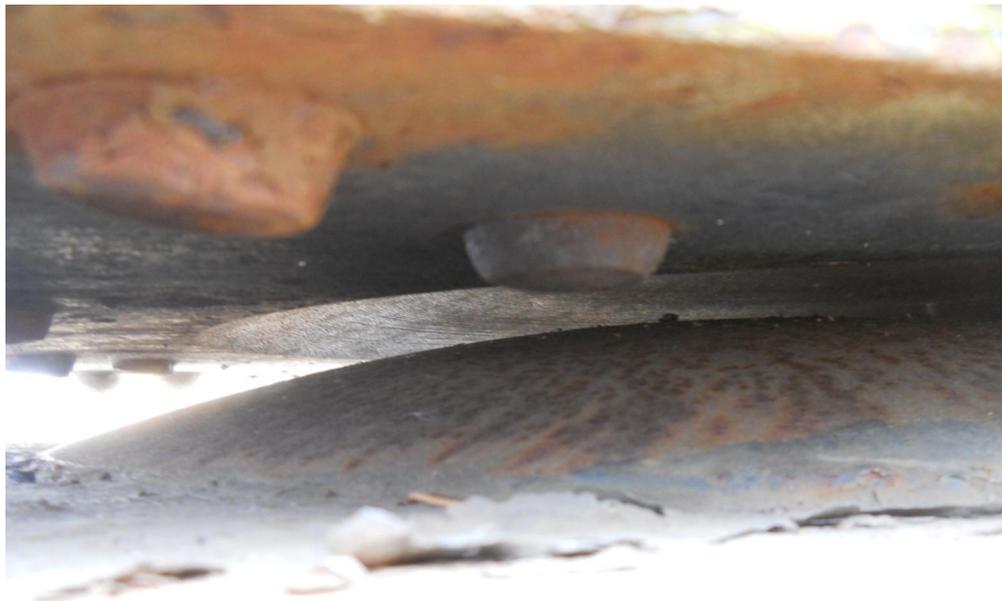
20131031 - Photo_18 - Gap between spherical bearing plates at W4 south bearing

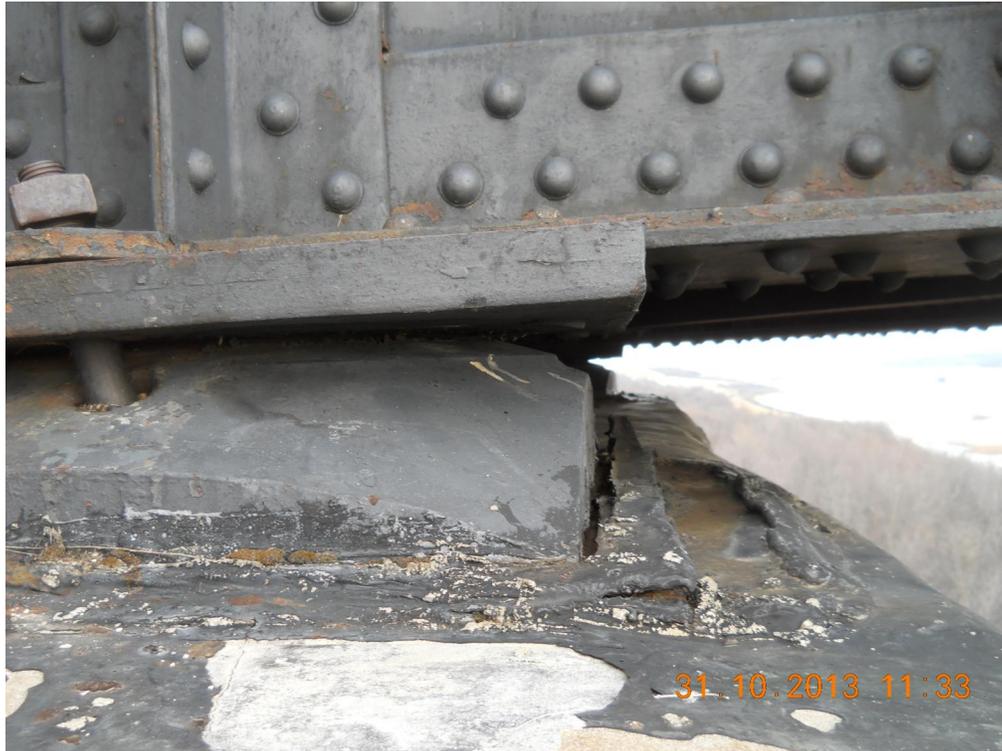
20131031 - Photo_19 - Movement of west approach span girders at west abutment

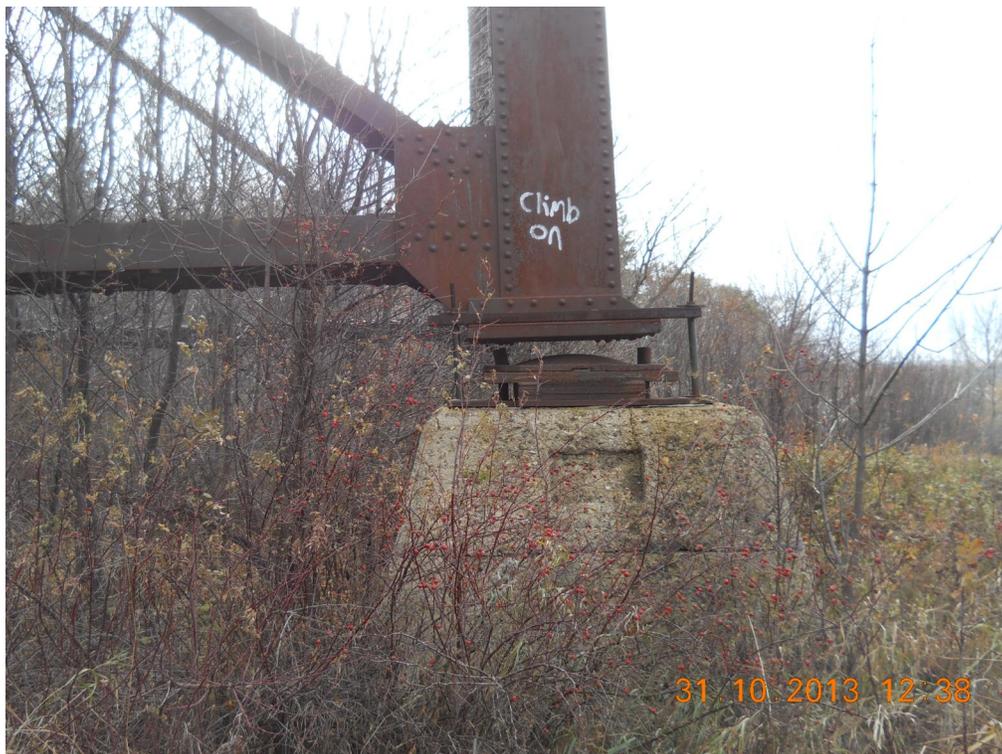
20131031 - Photo_20 - Significant gap between bearing plates at support bent E8

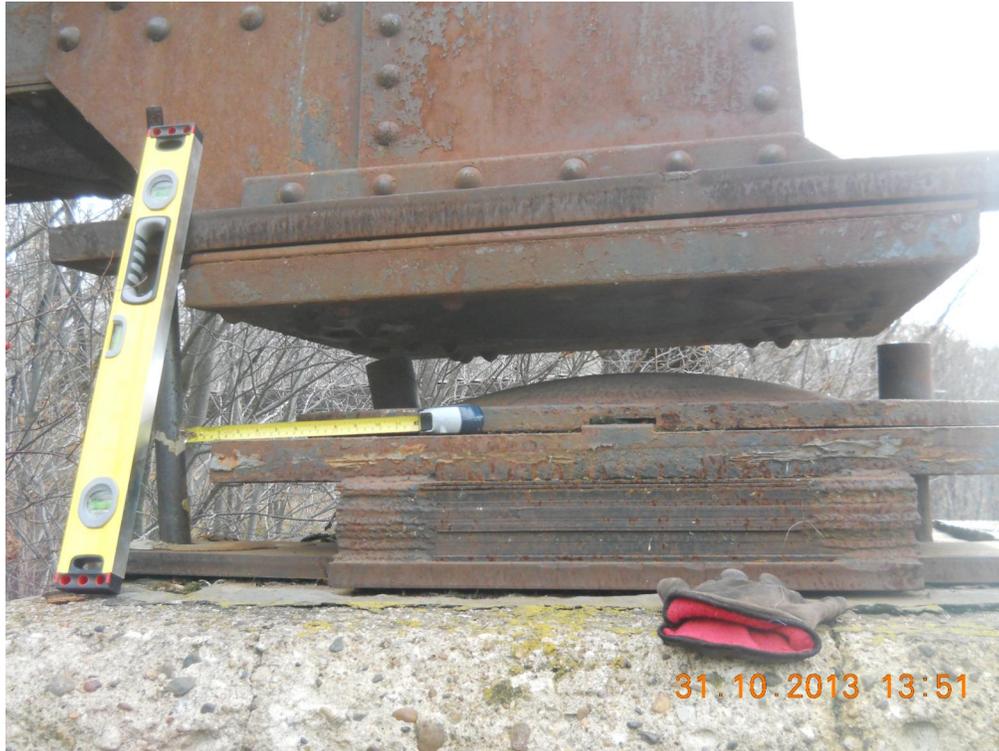
20131031 - Photo_21 - Significant gap between bearing plates at support bent E8

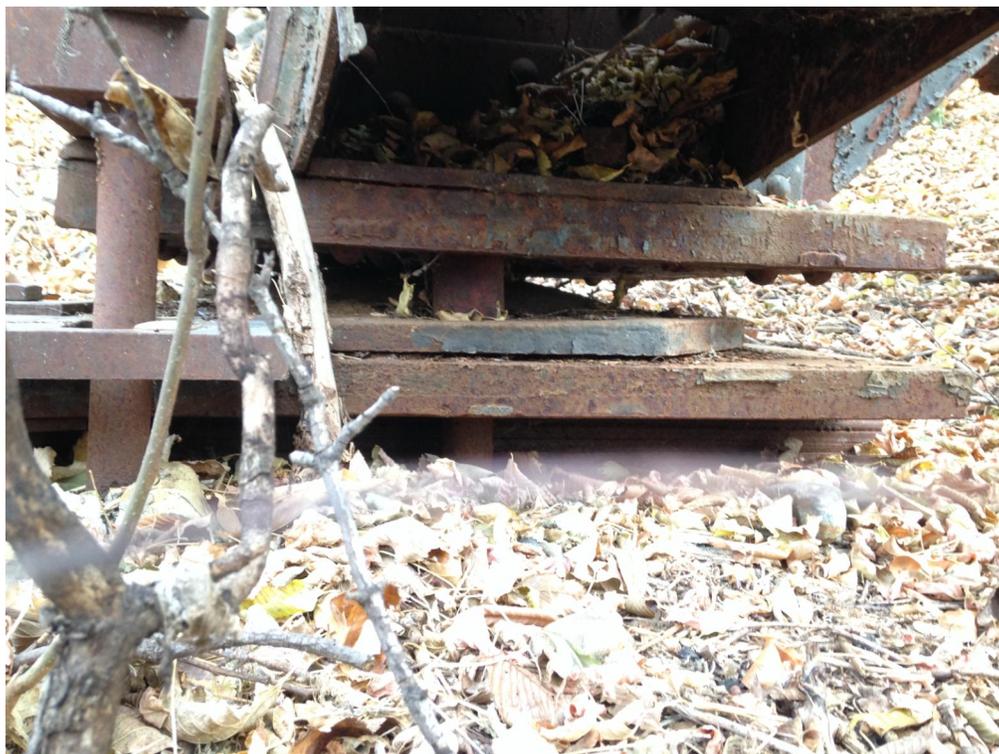
20131031 - Photo_22 - Gap between bearing plates, typical for several east approach bent supports

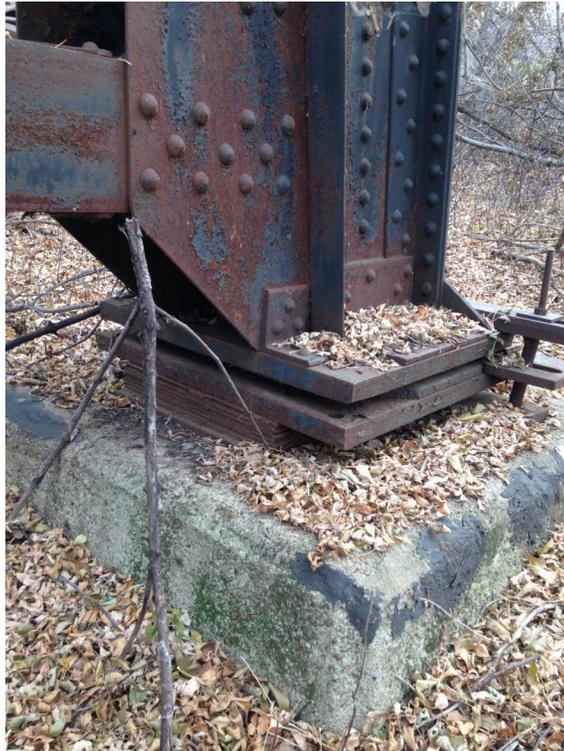
20131031 - Photo_23 - Shim plates below bearing seat, typical several locations
