Town of Outlook

TransCanada Trail Pedestrian Bridge Preliminary Bridge Repair Design Report

April 2014

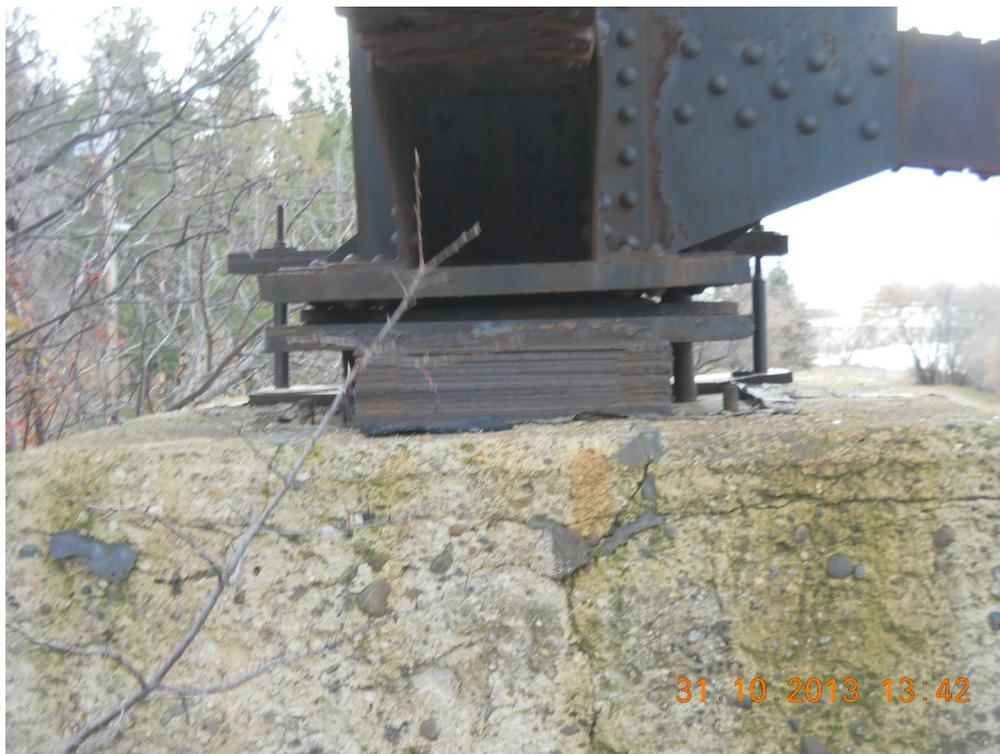
20131031 - Photo_24 - Shim plates below bearing seat, typical several locations
