P.MACHIBRODA ENGINEERING LTD.

May 7, 2020

RE: SLOPE STABILITY STUDY – OVERLAY MAPS EAST BANK – SOUTH SASKATCHEWAN RIVER OUTLOOK, SASKATCHEWAN PMEL PROJECT NO. 16030

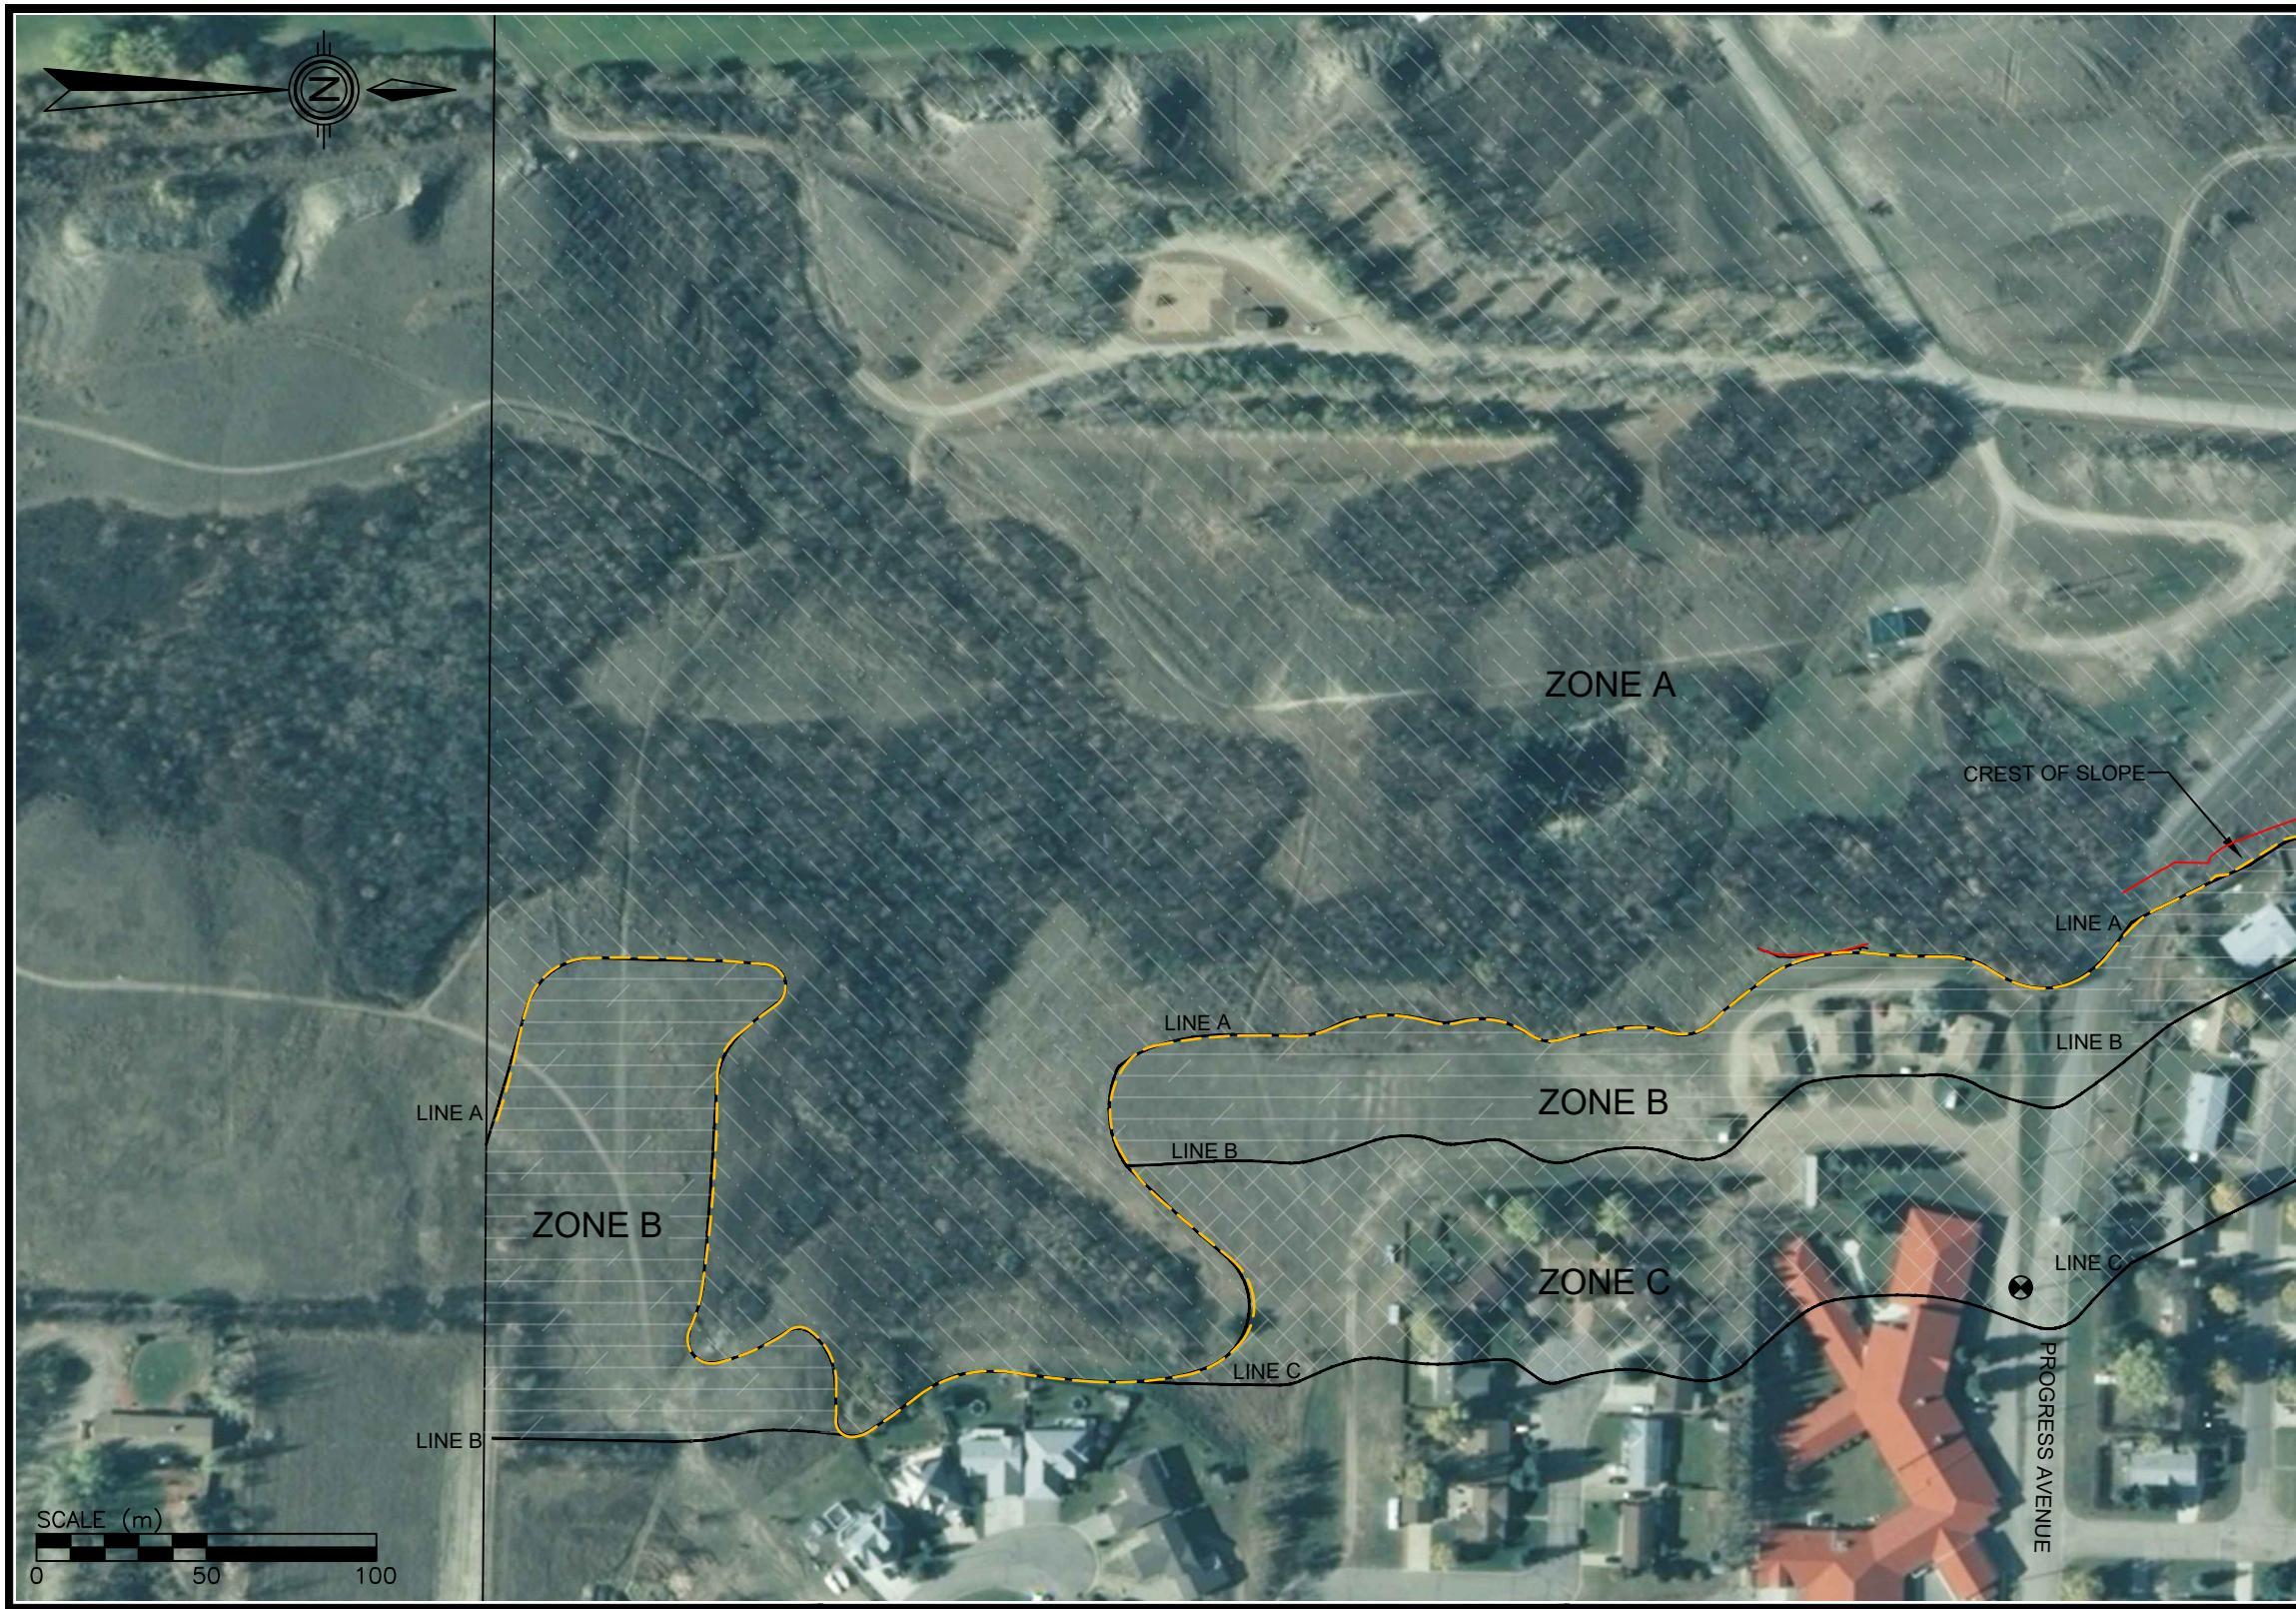
TH 17-24, 28
TH 17-5A	
TH 17-	1B. 10.
Т	UFTS CRESCENT
DRAWING TITLE: OVERL/ PROGRESS AVENU	AY PLAN E TO PARK AVENUE
PROJECT: SLOPE STAE EAST BANK OF SOUTH SASKA	BILITY STUDY
APPROVED BY: GB	DRAWN BY: SD
DATE: SEPTEMBER, 2019 SCALE: AS SHOWN	DRAWING NUMBER: 16030-1

ZONE A: AREA OF HISTORICAL AND ACTIVE LANDSLIDES. AREA HAS/IS EXPERIENCING SLOPE MOVEMENT.

ZONE B: AREA WITH NO OBVIOUS CURRENT SLOPE MOVEMENT BUT CONSIDERED AT MODERATE TO HIGH RISK OF SLOPE MOVEMENT IN FUTURE.

ZONE C: AREA WITH NO SLOPE MOVEMENT AND CONSIDERED TO HAVE A LOW RISK OF SLOPE MOVEMENT OCCURRING IN FUTURE.

Further explanation on the three zones have been presented below. The zones have been shown on attached Drawing Nos. 16030-1, 2 and 3.

Zone A consists of the area between Line A and the river. This zone is within historical and active landslide areas and is experiencing slope movement. Many structures (i.e., houses, bridge, pool, pumping station, etc.) within this zone have experienced differential movement due to slope movement and as a result have experienced differing degrees of damage. As such, this zone is considered at a very high risk of further slope movement and property owners should be aware that this could result in damage to properties and structures.

Zone B consists of the area approximately between the crest of slope (Line A) and 35 m upslope (Line B). This zone does not appear to be within a historical landslide area and there are no obvious signs of current slope movement impacting properties in this zone. Though the slope movement has generally been observed along the slope (downslope of the crest of slope), there is one known area in which a landslide block has formed upslope of the crest of slope (along Tuft Crescent). As such, it is considered that there is a moderate to high risk of slope movement potentially occurring within Zone B in the long-term.

Zone C consists of the area approximately between 35 m (Line B) and 100 m (Line C) from the crest of slope. This zone is generally well outside the historical landslide area and there are no signs of current slope movement impacting properties in this zone. The risk of slope movement potentially occurring within this zone is considered low. Due to the distance from the existing active/historical landslide areas, it is anticipated that any new landslide blocks would form within Zone B prior to impacting any properties in Zone C.

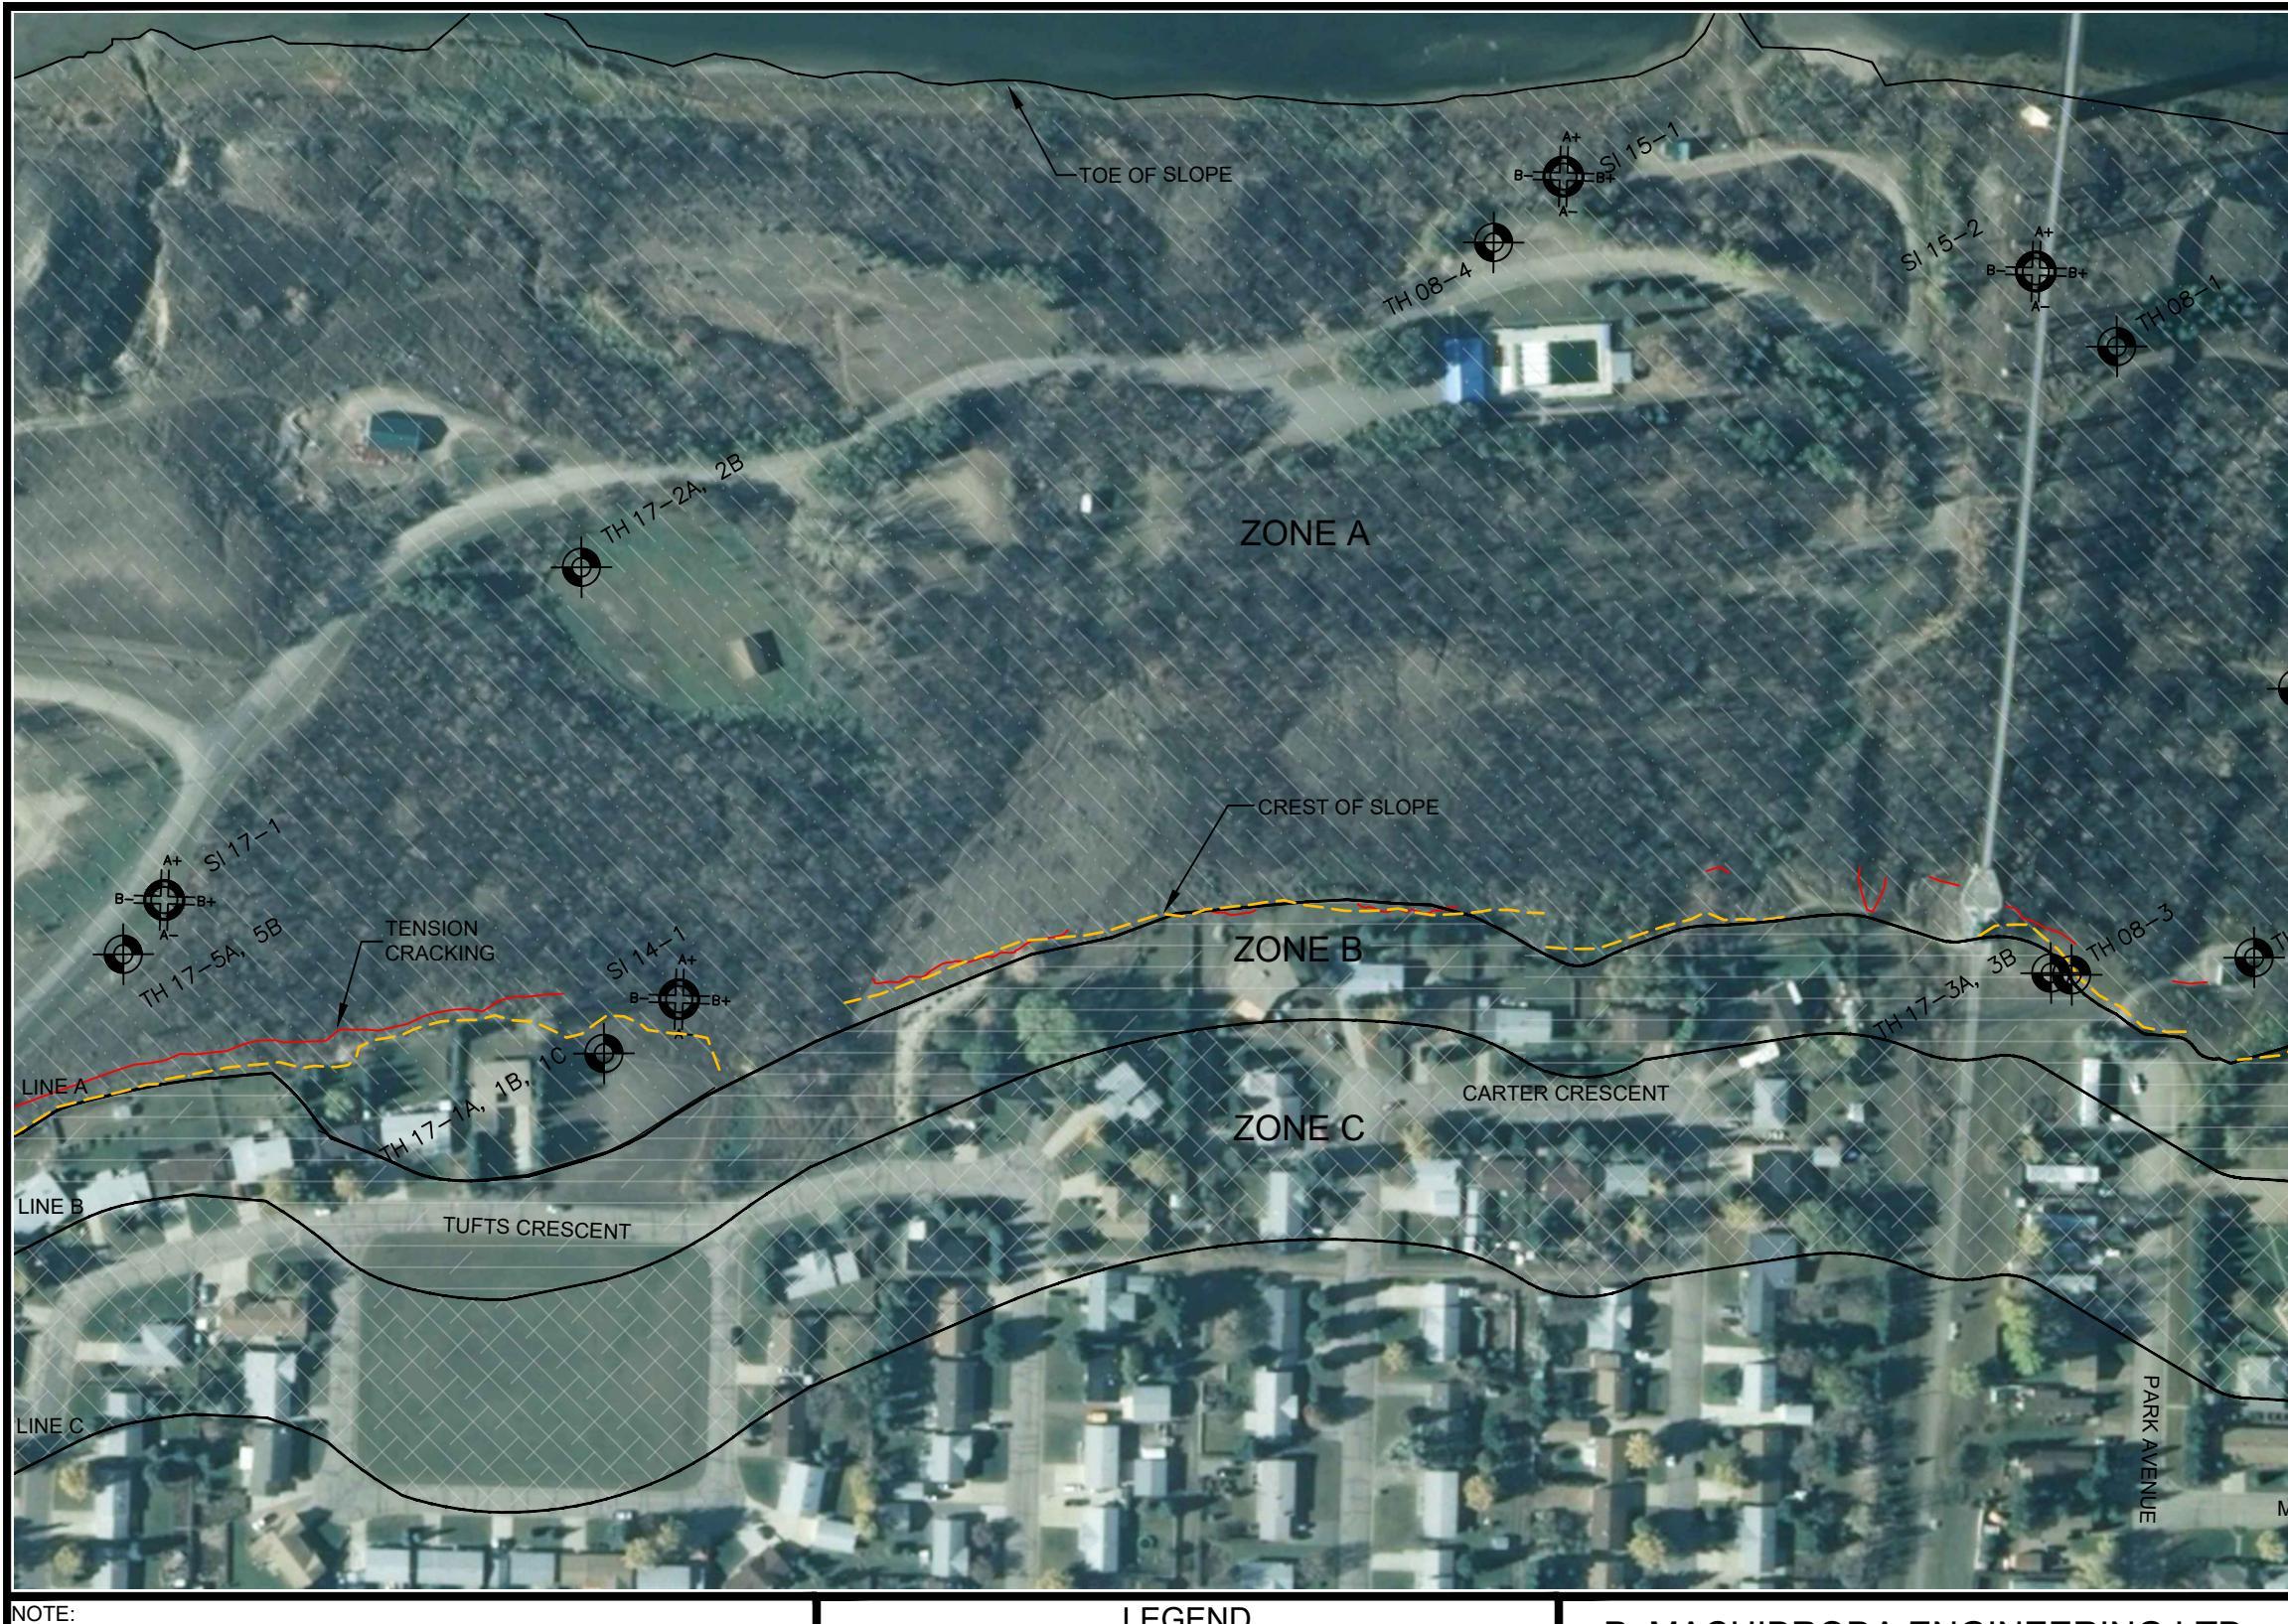
ANTINITIAN STREET	
2	
TH	
AB	
117 AM	
	LINEA
	LINE B
MAPLE STREET	
	LINEC
DRAWING TITLE:	ΔΥ ΡΙ ΔΝ
PROGRESS AVENU	E TO PARK AVENUE
PROJECT: SI OPF STAF	
EAST BANK OF SOUTH SASKA	TCHEWAN RIVER OUTLOOK, SK
APPROVED BY:	DRAWN BY:
DATE: SEPTEMBER. 2019	DRAWING NUMBER:
SCALE: AS SHOWN	16030-2

ZONE A: AREA OF HISTORICAL AND ACTIVE LANDSLIDES. AREA HAS/IS EXPERIENCING SLOPE MOVEMENT.

ZONE B: AREA WITH NO OBVIOUS CURRENT SLOPE MOVEMENT BUT CONSIDERED AT MODERATE TO HIGH RISK OF SLOPE MOVEMENT IN FUTURE.

ZONE C: AREA WITH NO SLOPE MOVEMENT AND CONSIDERED TO HAVE A LOW RISK OF SLOPE MOVEMENT OCCURRING IN FUTURE.

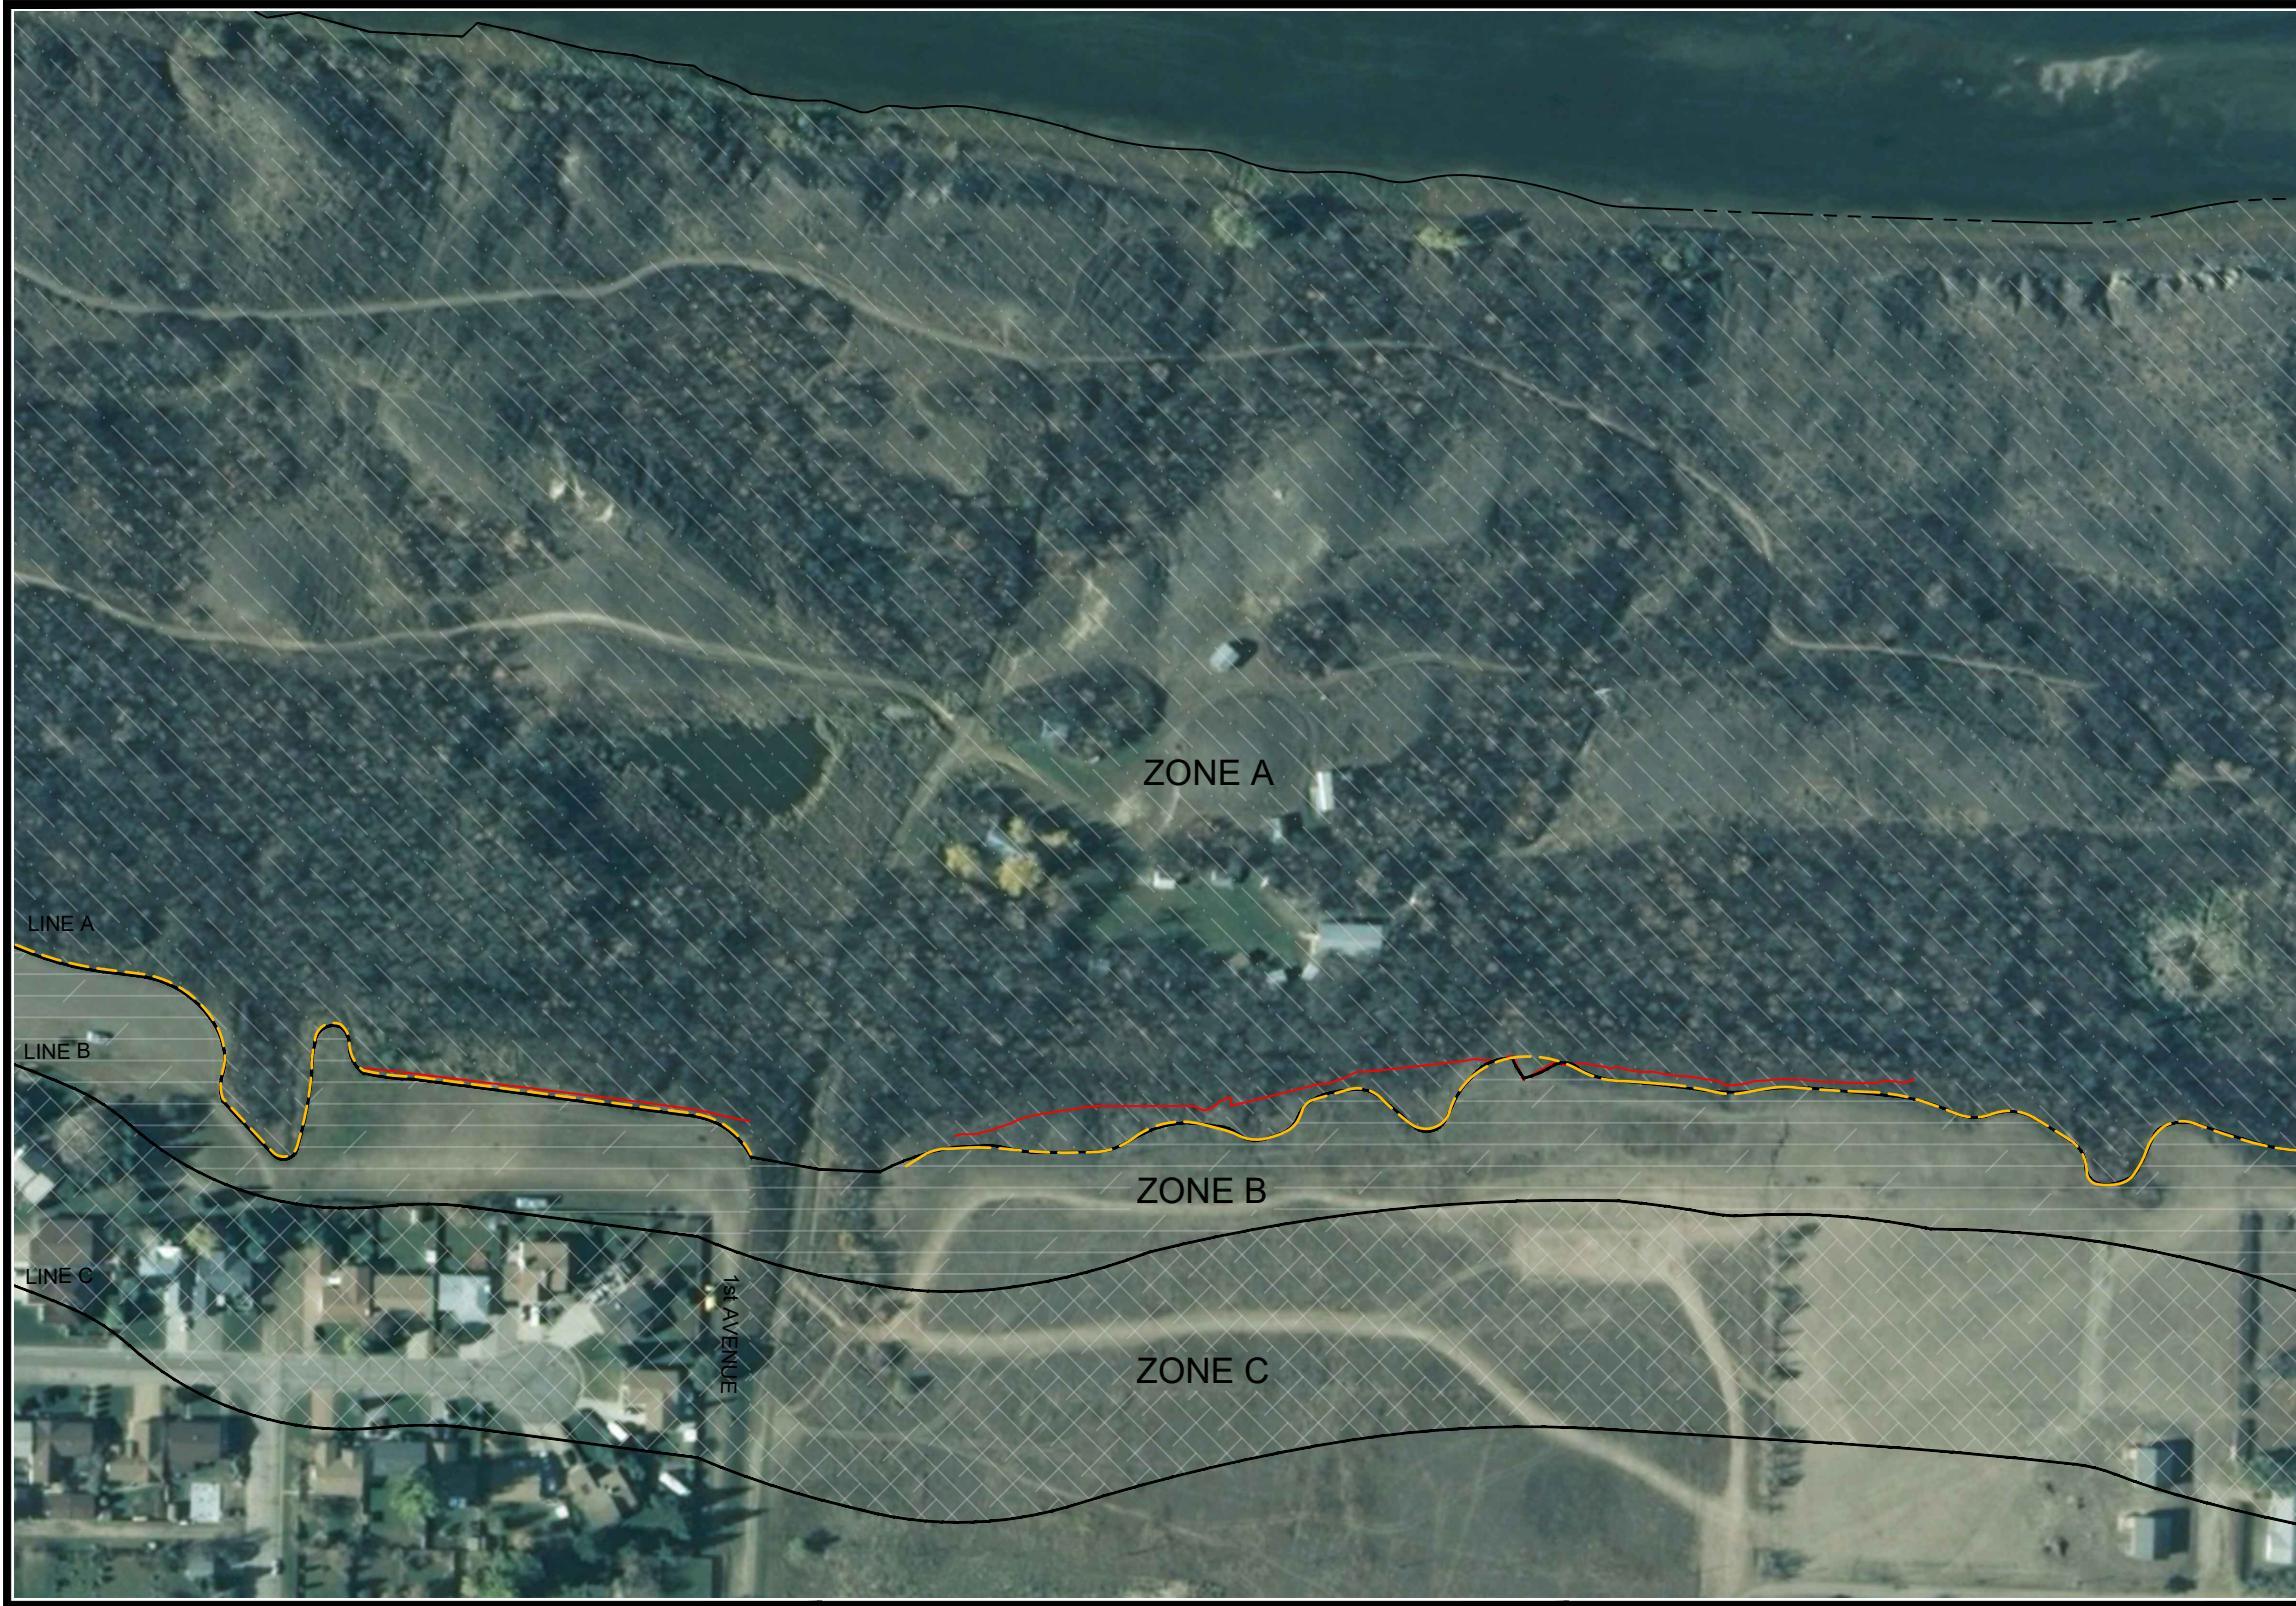
A CONTRACTOR OF THE OWNER	The second se	
	ATT.	
	LINEA	
6 - 9 - 8 - 8 - 8 - 8 - 8 - 8 - 8 - 8 - 8	LINEC	
DRAWING TITLE:		
OVERLAY PLAN PARK AVENUE TO 1st AVENUE		
PROJECT:		
SLOPE STABILITY STUDY		
APPROVED BY:	DRAWN BY:	
GB	SD	
DATE: SEPTEMBER, 2019	DRAWING NUMBER:	
SCALE: AS SHOWN	10030-3

ZONE A: AREA OF HISTORICAL AND ACTIVE LANDSLIDES. AREA HAS/IS EXPERIENCING SLOPE MOVEMENT.

ZONE B: AREA WITH NO OBVIOUS CURRENT SLOPE MOVEMENT BUT CONSIDERED AT MODERATE TO HIGH RISK OF SLOPE MOVEMENT IN FUTURE.

ZONE C: AREA WITH NO SLOPE MOVEMENT AND CONSIDERED TO HAVE A LOW RISK OF SLOPE MOVEMENT OCCURRING IN FUTURE.
